Water Quality Report
For
The Silvermine River and Lower Norwalk River Storm Drains
May Through August 2014

SM4 in Zone B of the Silvermine River

Index of Figures and Tables	3
Acknowledgements	4
Abstract	5
Introduction	6
Research Zones	6
Methods and Procedures (Zones A, B, and Lower Norwalk Storm Drains)	10
Section I	
Introduction, Zone A (Upper Silvermine River)	11
Results, Zone A	11
Discussion, Zone A	14
Section II	
Introduction, Zone B (Lower Silvermine River)	15
Results, Zone B	15
Discussion, Zone B	18
Section III	
Introduction, Lower Norwalk River Storm Drains	19
Results, Storm Drains	19
Discussion, Zone Drains	23
Final Conclusions for the Silvermine River and Norwalk River Storm Drains	24
Appendix A References	24
Appendix B Photographs	25

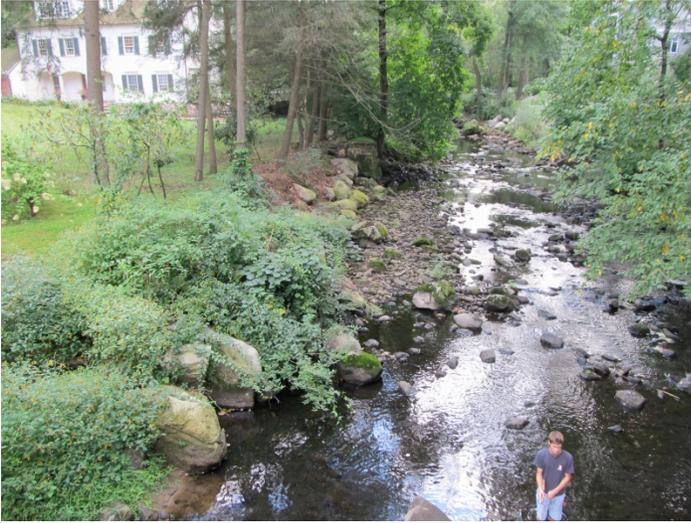
Stream bank erosion at site SM3

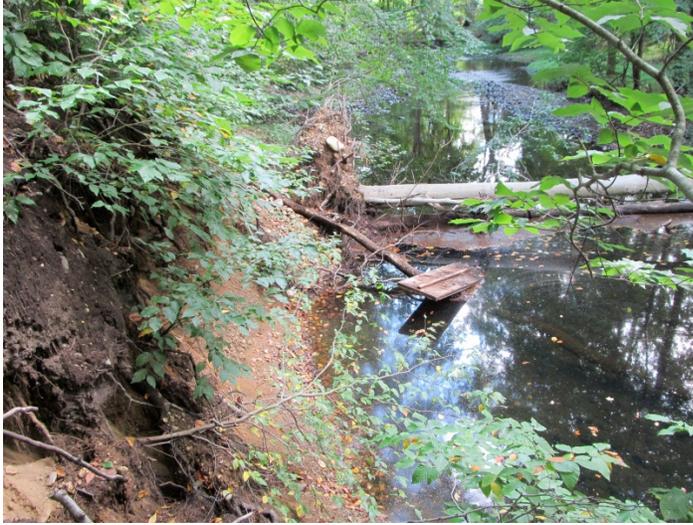
The lower Silvermine River, from site SM5 at the Silvermine School to site SM3 at James Street (Figure 2) appears to be continually affected by poor property management, including the mowing of lawns to the edge of the river, which results in erosion of the riverbank. A historical example of such an occurrence can be seen behind the Silvermine Elementary School, where the Norwalk River Watershed Initiative tried to stabilize the banks with “J hooks”, or large stone emplacements, to deflect the water away from the west bank (Appendix B). A very large storm on April 15, 2007 accomplished just the opposite. The J hooks were overridden, the west bank was severely eroded with the loss of trees, and the river bed shifted twenty feet to the west (Appendix B). No effort, with the exception of the removal of fallen trees by the city of Norwalk, was made to repair the damage. Another good example of stream bank erosion is found at HW monitoring site SM4 (Figure 2, Appendix B). Trees continue to fall here as the river undercuts the banks.

Example of severe bank erosion and fallen trees at site SM4

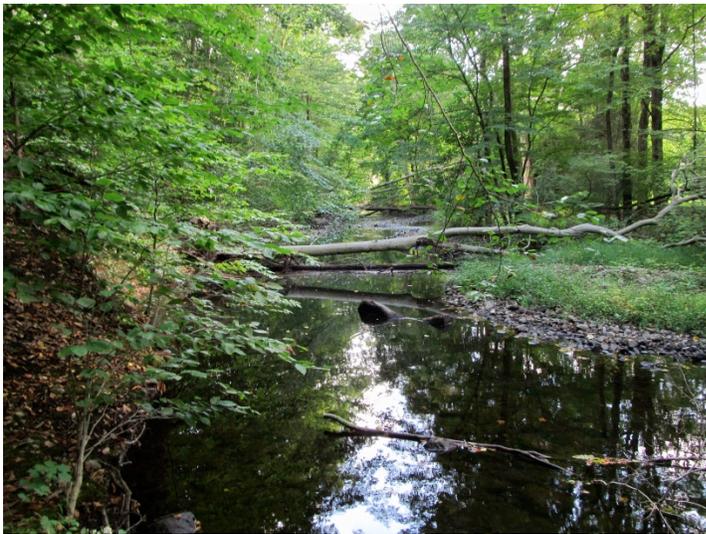
Alternate view of site SM4 showing the number of fallen trees

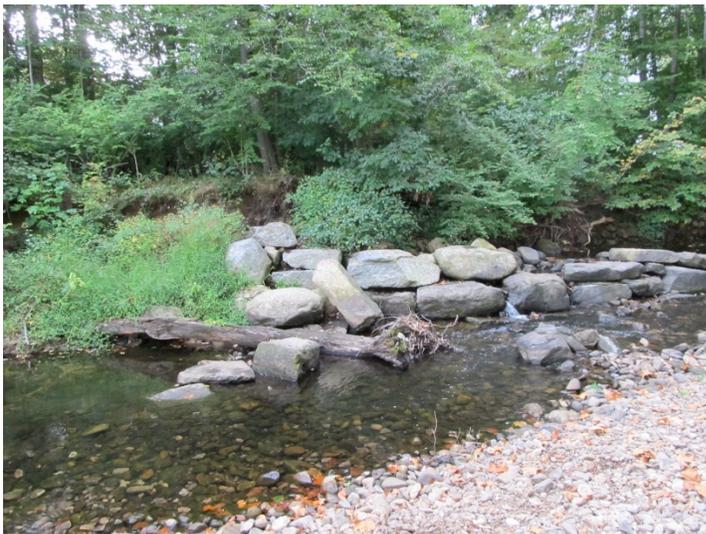
Remaining pieces of J-hooks that were installed in early 2000s at site SM5. Stream bank erosion can be seen in the background.

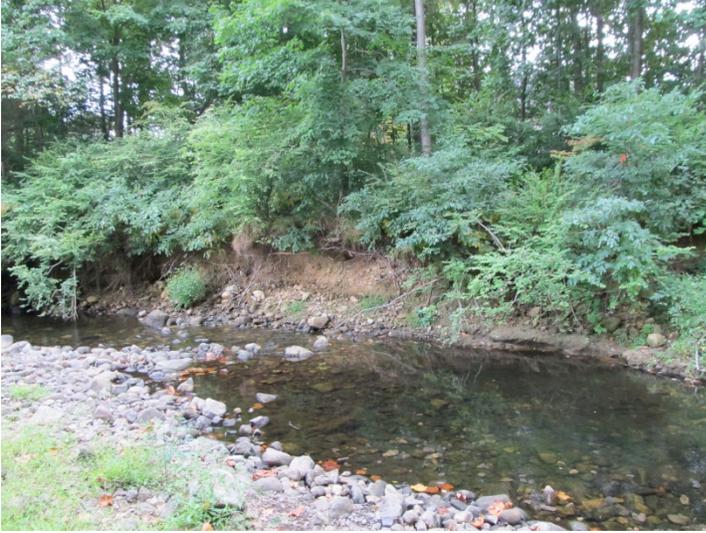
SM5, behind the Silvermine School, showing the erosion caused by J-hooks installed in the early 2000s
