Water Quality Data Report
For
The Silvermine River and the Lower Norwalk River Storm Drains
May through August 2013

Submitted by:

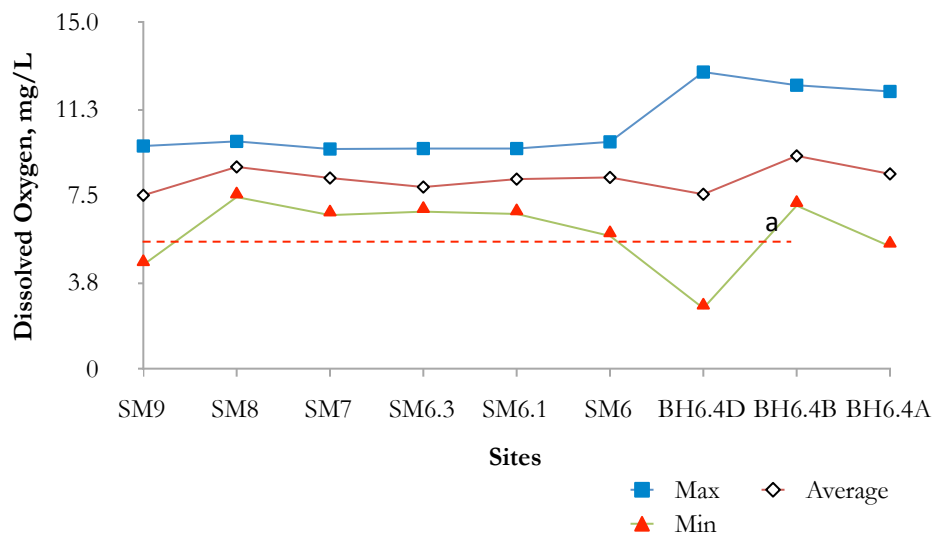
Figure 7 Observed maximum, mean, and minimum values for dissolved oxygen at six monitoring sites in Zone A of the Silvermine River and three sites on Belden Hill Brook from May to August 2013

Observed dissolved oxygen (DO) mean value at all sites in Zone A met the CT DEEP criterion of $\geq 5\text{mg/L}$ for dissolved oxygen. Individual readings at sites SM9 and BH6.4D were below 5mg/L of 4.5mg/L and 2.6mg/L respectively (Figure 7). Both of these readings were observed on 7/9/13.

a CT DEEP average minimum limit for a Class B River

Despite a couple of individual data points not meeting the CT DEEP criterion for dissolved oxygen (DO), Zone A had acceptable DO readings. While water levels were lower due to the lack of rain, the tree cover along the river helps to limit the effects of the increasing water temperatures.

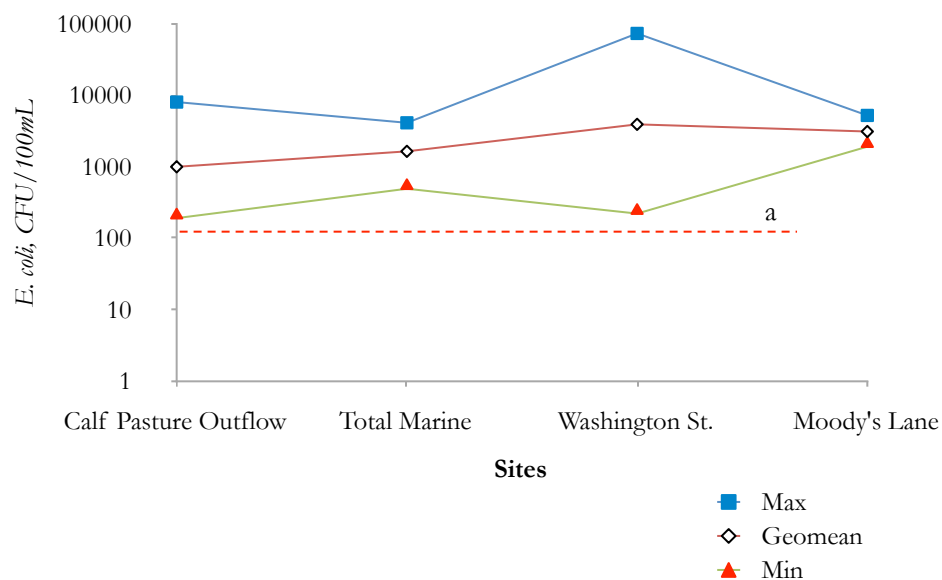
Figure 13 Observed maximum, geometric mean, and minimum values for *E. coli* at four saltwater storm drains in Norwalk Harbor from May to August 2013

All four saltwater storm drains exceeded the CT DEEP geometric mean criterion for a Class B river for *E. coli* of <126CFU/100mL (Figure 13, Table 6). The four saltwater storm drains also exceeded the CT DEEP single sample maximum criterion of <10% of samples taken being <576CFU/100mL (Table 6). Three of the five freshwater storm drains: School St., New Canaan Ave., and Linden Ave. exceeded the CT DEEP geometric mean criterion and all but the Perry Ave storm drain site exceeded the CT DEEP single sample maximum criterion (Figure 14, Table 7).

a CT DEEP geometric mean maximum for a class B river

The pollution problems associated with most of the storm drains that continually discharge to the marine environment is based on age of the system and lack of maintenance. Most of these pipelines are in the older sections of Norwalk and may have been altered many times to meet surface development. As a result records are not always accurate. Sewage may be infiltrating the storm drain networks because of aging infrastructure, existing crossovers, and/or illegal hookups. Many of these problems stem from the fact that adjoining sanitary lines (some are over 70 years old) are made with clay pipe which deteriorates over time allowing sewerage to migrate through the soil and infiltrate adjoining storm drains. Many of these storm drains are made of reinforced concrete or galvanized metal pipe and have developed small leaks at the joints over many years which allow waste water products to enter the system (Table 6)..

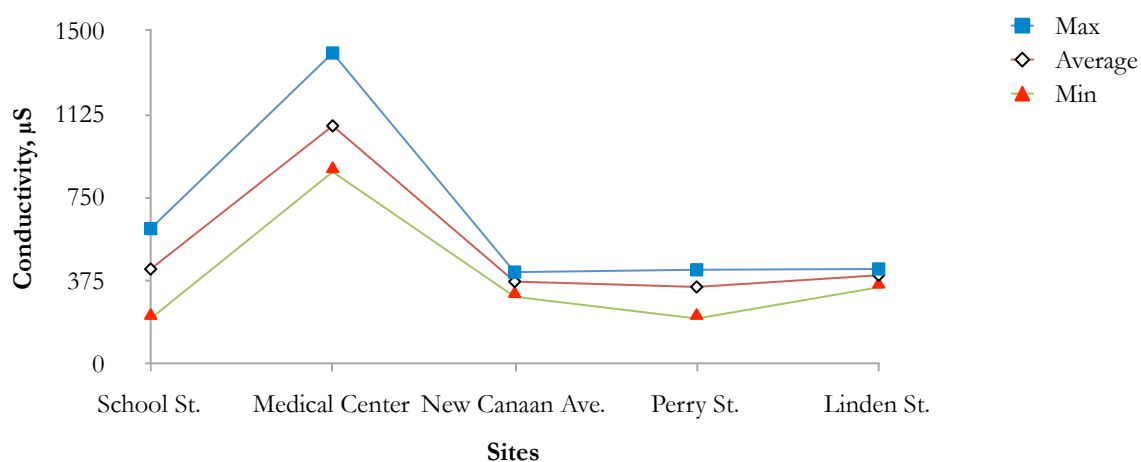
Figure 16 Observed maximum, mean, and minimum values for conductivity at five freshwater storm drains on the Norwalk River from May to August 2013

Among the saltwater storm drains conductivity means ranged from a minimum of 8,536 μ S at Moody's Lane to a maximum of 33,781 μ S at Total Marine. Washington St. had the smallest conductivity range at 10,259 μ S, and Calf Pasture Beach Outflow had the largest conductivity range of 33,397 μ S (Figure 15, Table 8). Among the freshwater sites Perry Ave had the lowest mean conductivity at 347 μ S and Medical Center had the highest mean conductivity at 1,072 μ S. Linden St. had the smallest range at 83 μ S and Medical Center had the widest range at 535 μ S (Figure 16, Table 9).

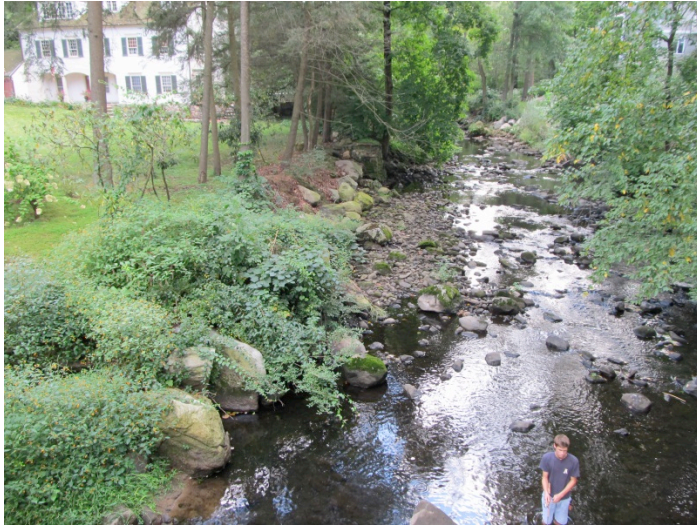
Stream bank erosion at site SM3

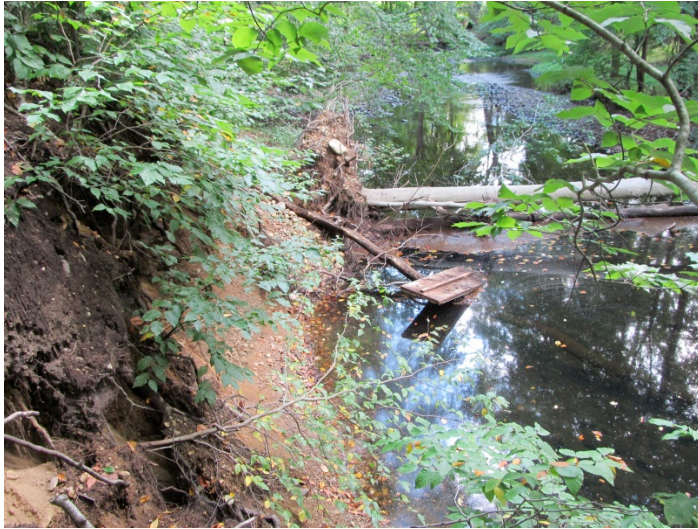
Example of severe bank erosion and fallen trees at site SM4

The lower Silvermine River, from site SM5 at the Silvermine School to site SM3 at James Street (Figure 1, Figure 2) appears to be continually affected by poor property management, including the mowing of lawns to the edge of the river, which results in erosion of the riverbank. A historical example of such an occurrence can be seen behind the Silvermine Elementary School, where the Norwalk River Watershed Initiative tried to stabilize the banks with “J hooks”, or large stone emplacements, to deflect the water away from the west bank (Appendix B). A very large storm on April 15, 2007 accomplished just the opposite. The J hooks were overridden, the west bank was severely eroded with the loss of trees, and the river bed shifted twenty feet to the west (Appendix B). No effort, with the exception of the removal of fallen trees by the city of Norwalk, was made to repair the damage. Another good example of stream bank erosion is found at HW monitoring site SM4 (Figure 2, Appendix B). Trees continue to fall here as the river undercuts the banks.

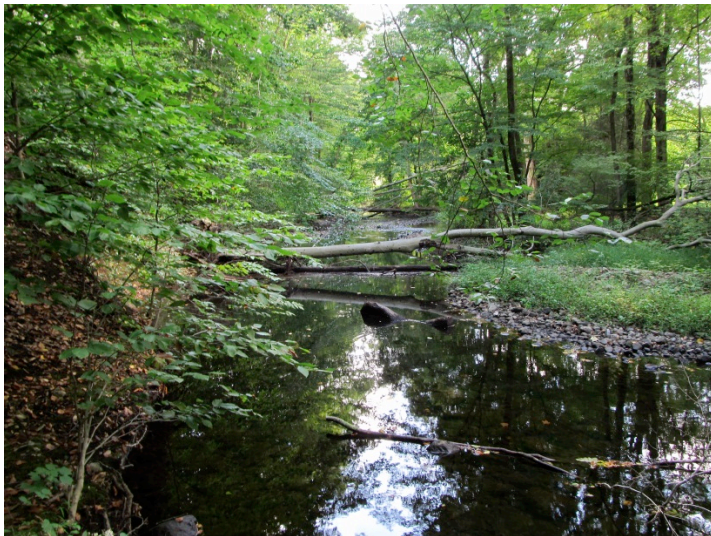
Alternate view of site SM4 showing the number of fallen trees

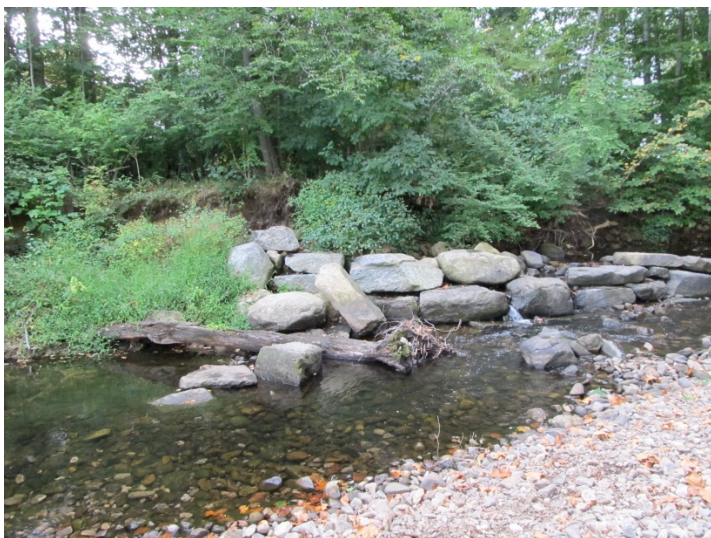
Remaining pieces of J-hooks that were installed in early 2000s at site SM5. Stream bank erosion can be seen in the background.

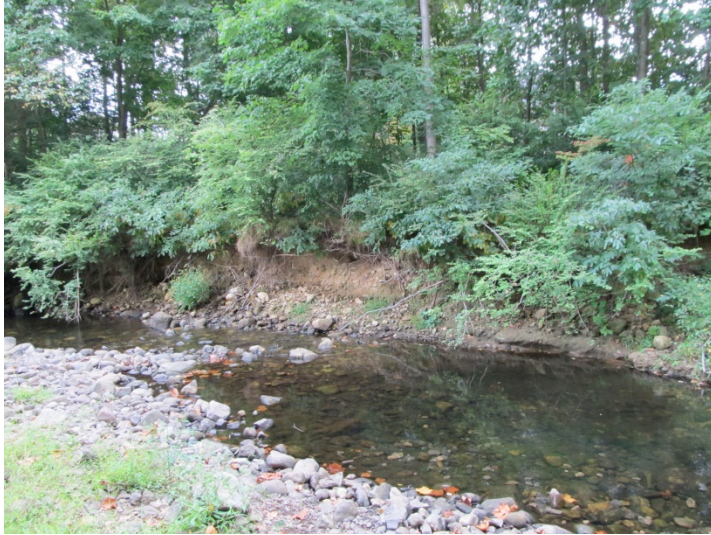
SM5, behind the Silvermine School,
showing the erosion caused by J-hooks
installed in the early 2000s
