**Harbor Watch, a Program of Earthplace
Report on Dissolved Oxygen Conditions in Norwalk Harbor
May – October 2015**

Introduction:

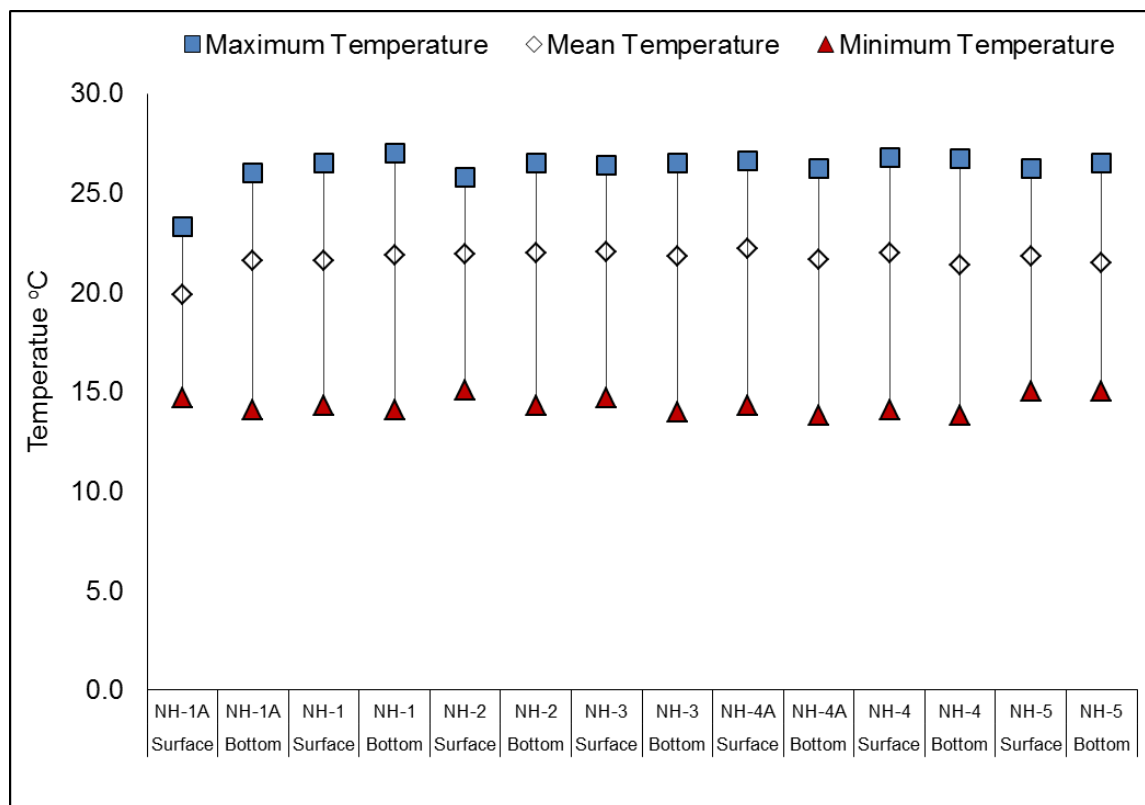
Figure 10. Maximum, mean, minimum surface and maximum, mean, and minimum bottom temperatures at the seven monitoring stations in Norwalk Harbor

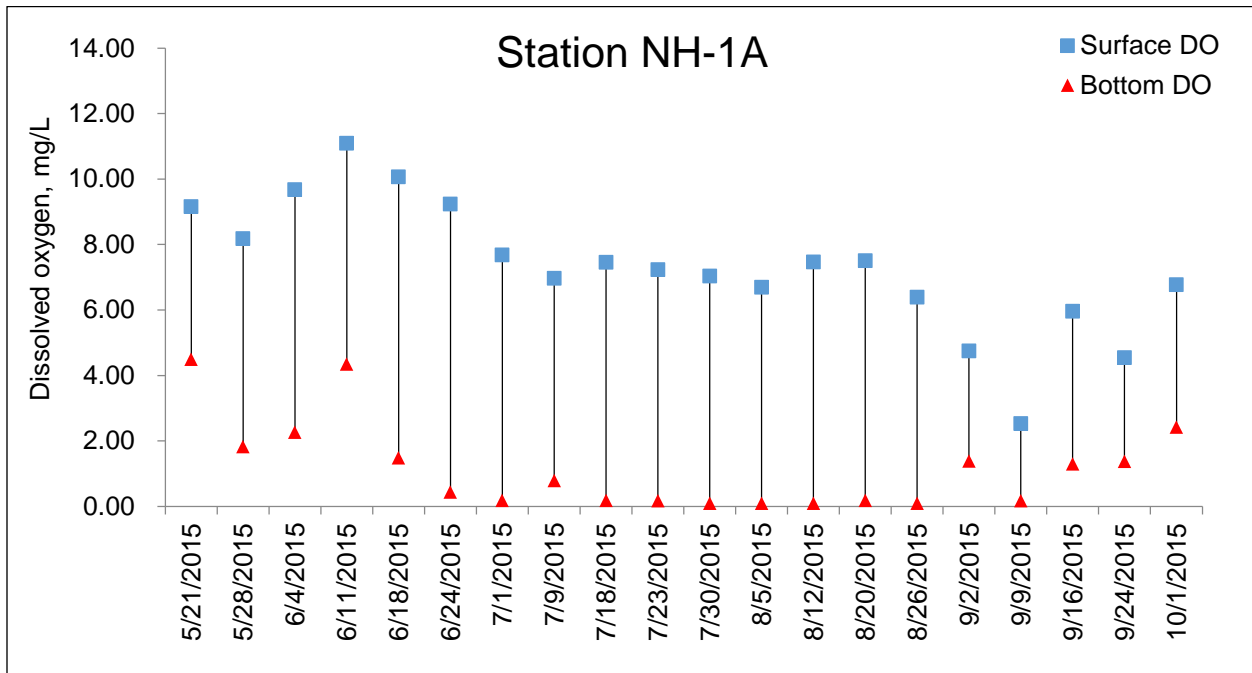
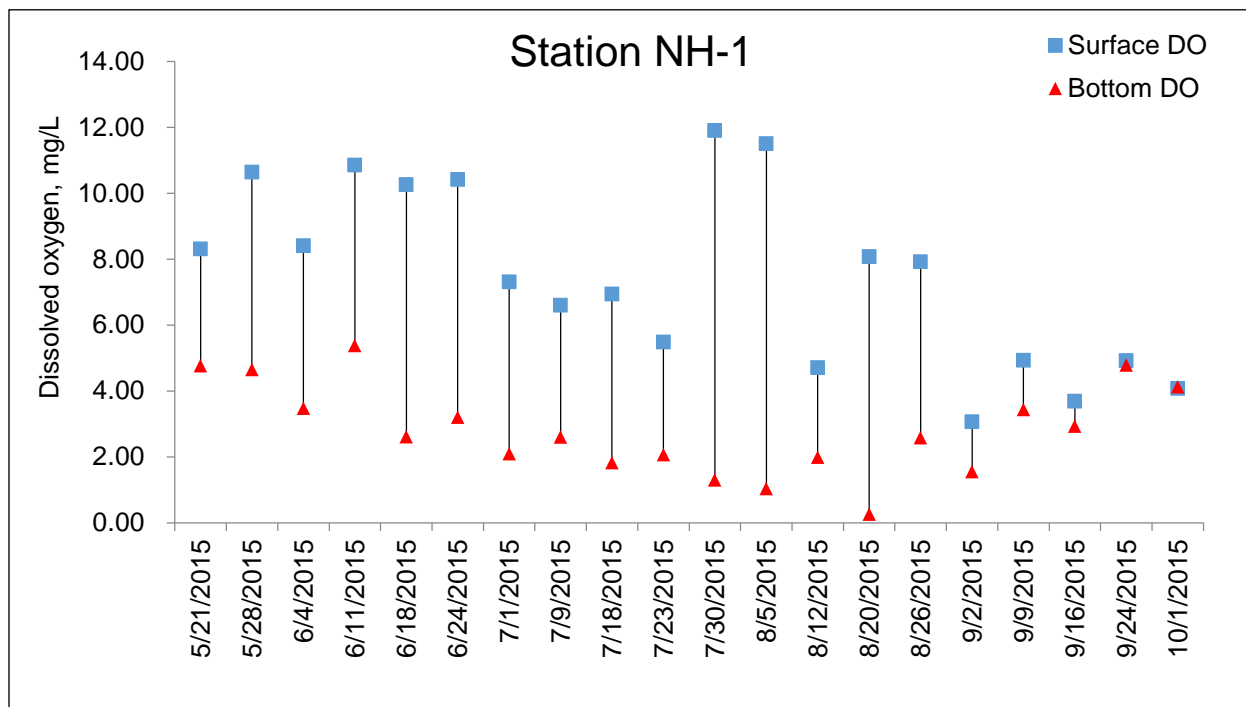
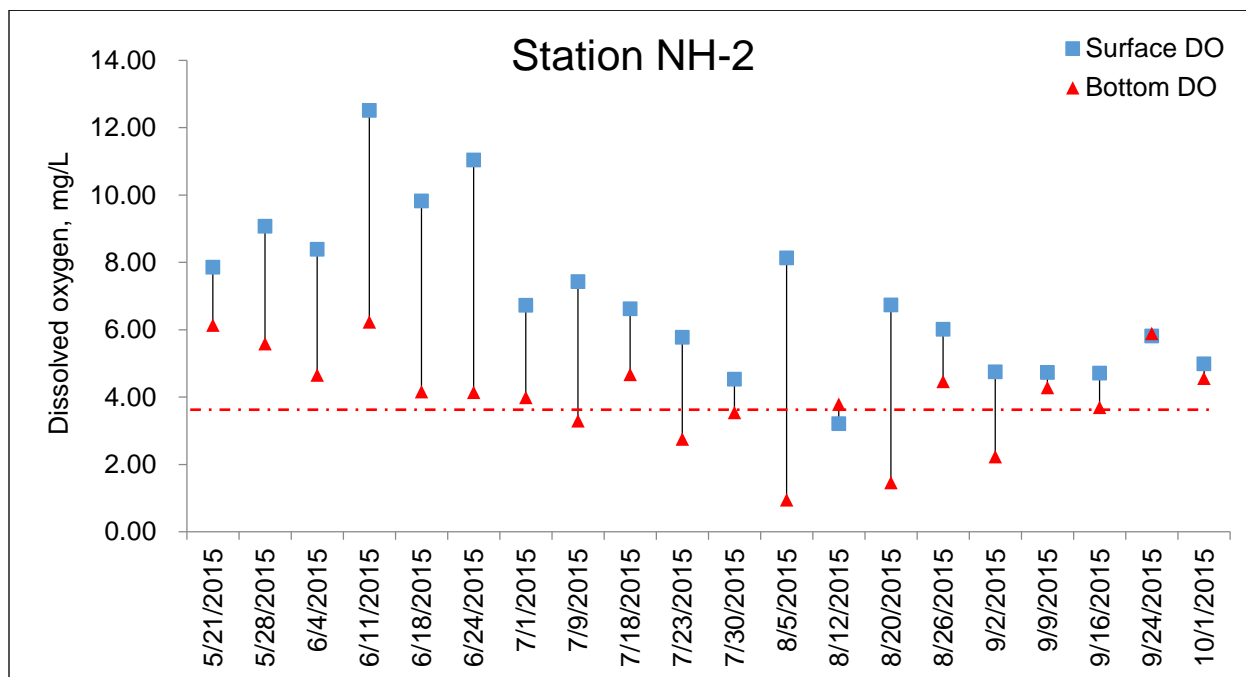
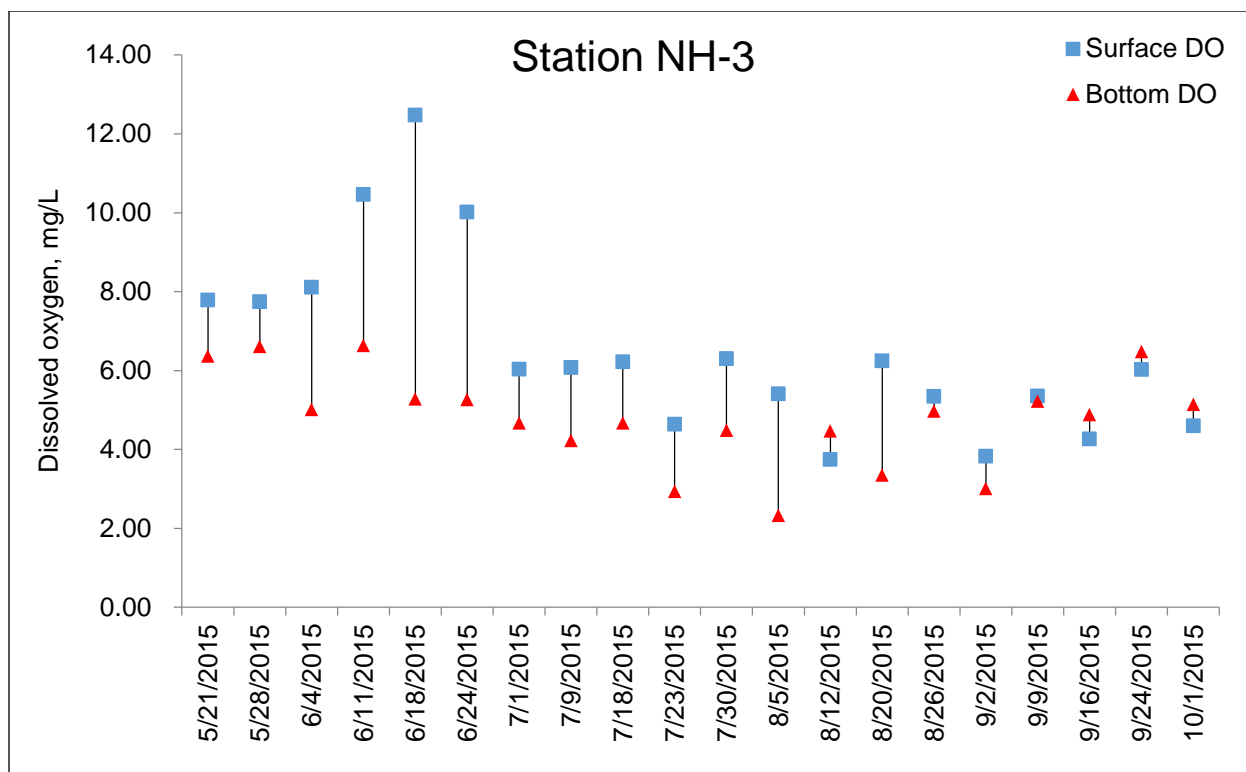
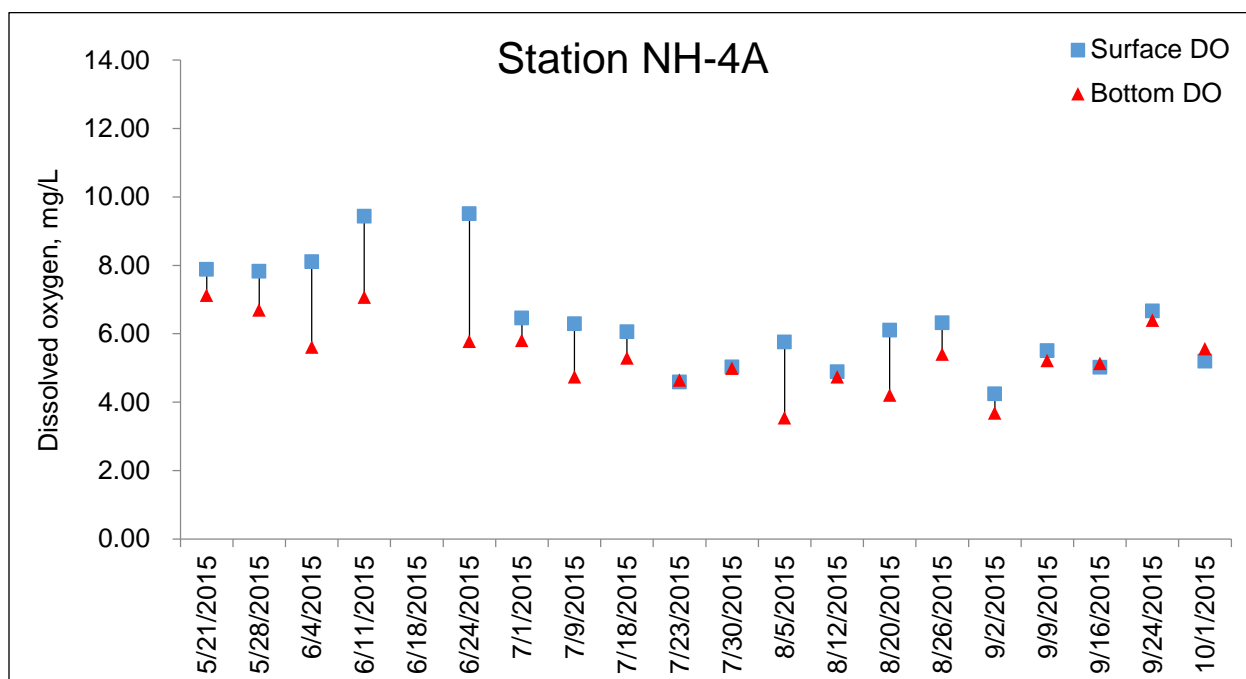
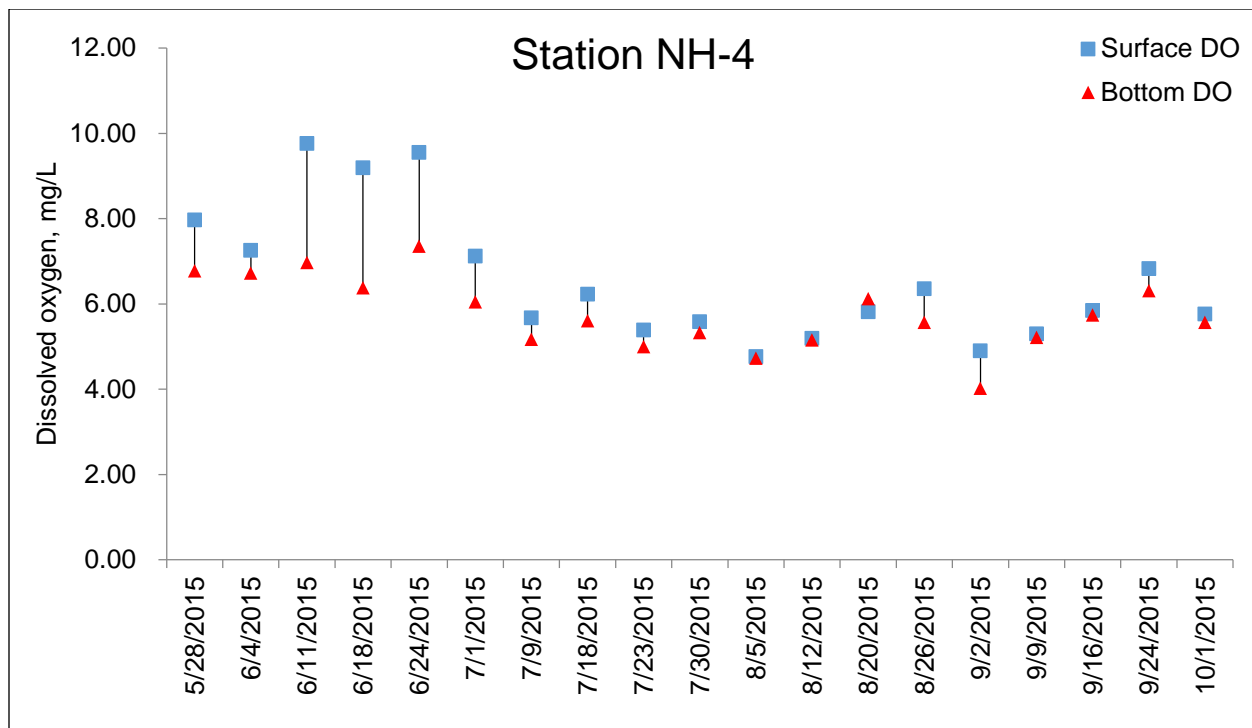
Surface and bottom dissolved oxygen levels at each of six stations in Norwalk Harbor during the 2015 monitoring season. **Please note that the relatively lower concentrations observed at more inland sites are likely to be an artifact of sampling design, as stations were sampled in order from inland (NH-1A) outward (to NH-5) beginning early in the morning and continuing into the late morning. As a result, bottom water concentrations may have been lower at the stations further downstream than what was observed in this study due to the impact of daylight on dissolved oxygen (via photosynthesis).**

This harbor as restructured by man has developed a perpetual, seasonal zone of hypoxia at its northern end at Harbor Watch Station NH-1A (Appendix 1) which is typically observed each summer. Elevated water temperatures, dry weather and the presence of large schools of menhaden seeking refuge from predation in the harbor waters can accelerate this hypoxia. This oxygen-depleted water serves as a trap for schools of fish and can lead to large fish kills. Station NH-1A marks the toe of the tidal wedge and is at the entry point of the Norwalk River (Appendix 1). One of the last in a series of large fish kills occurred in the summer of 2005, when up to two million fish perished in the upper estuary after consuming the remaining dissolved oxygen available in the surface layer (mostly brackish river water).
