Appendix 1. Norwalk River Stressor Identification

Waterbody: Norwalk River and Ridgefield Brook

Designated Use Impairment: Aquatic Life Use Support

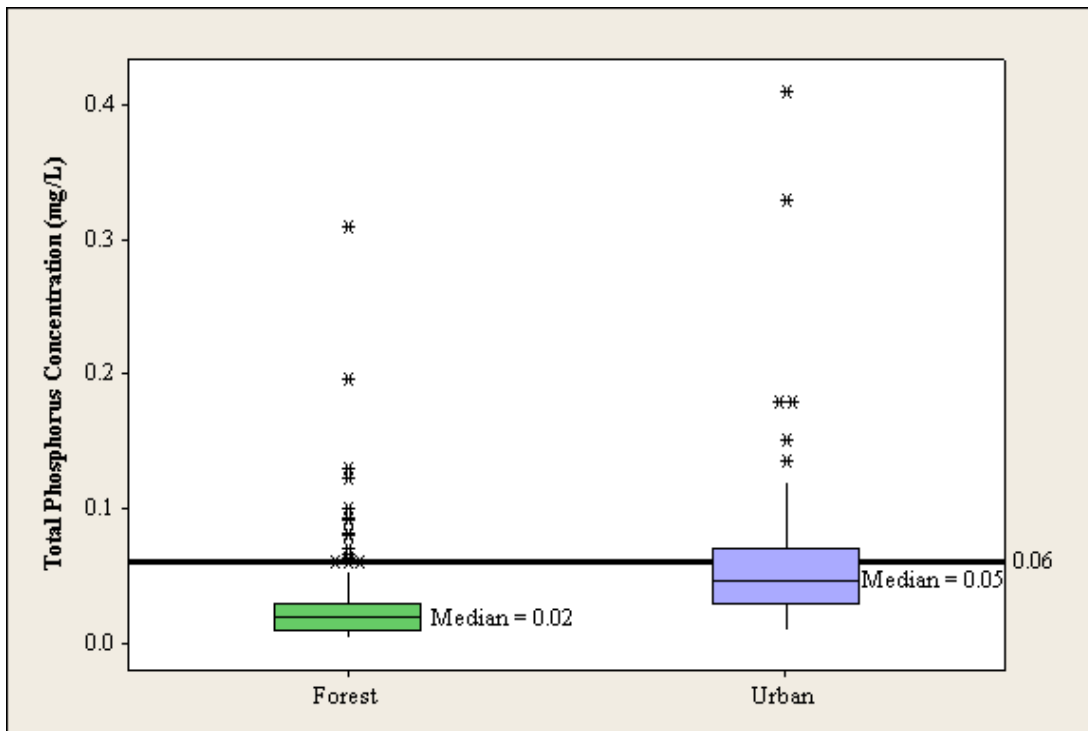
Figure 4. Relationship between total phosphorus concentration (mg/L) from streams in Connecticut and two landuse categories- forested (N=286) and urban (N= 138). The line at 0.06 mg/L represents the 75th percentile of sampled streams in the southwest coastal basin that was used in this evaluation (*should not be viewed as water quality criterion –see text for discussion* *).

- 19% Impervious Cover in watershed support landuse contributions of TP
- Connecticut DEP monitoring data show that urban landuse results in higher TP concentrations (Figure 4)
- Visual observations of the watershed show evidence of anthropogenic enrichment (Data Support Photo 1)

- Twenty two out of 34 samples from 5 locations > 0.06 mg/L Total Phosphorus (75th percentile of streams in southwest coastal basin) *
- 14 % Impervious Cover in watershed support landuse contributions of TP
- Connecticut DEP monitoring data show that urban landuse results in higher TP concentrations (Figure 4)

- Five out of 24 samples from four locations > 0.06 mg/L Total Phosphorus (75th percentile of streams in southwest coastal basin) *
- 16 % Impervious Cover in watershed support landuse contributions of TP
- Connecticut DEP monitoring data show that urban landuse results in higher TP concentrations (Figure 4)

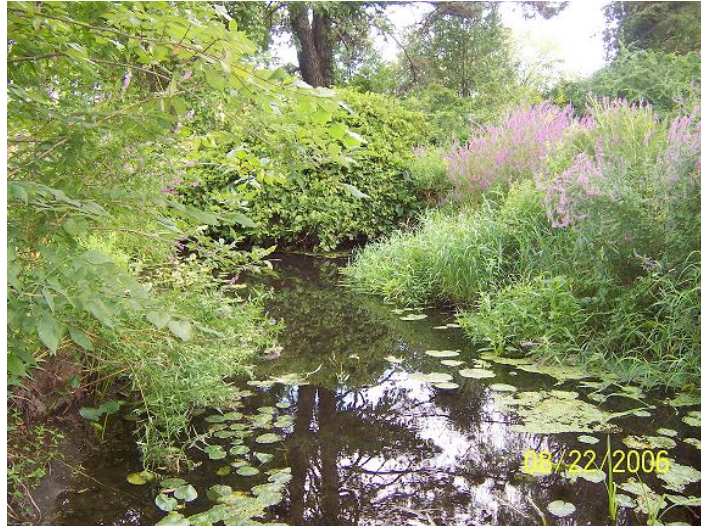
Data Support Photo 1. Ridgefield Brook at Route 35 Fox Hill Condos potentially caused by anthropogenic enrichment.

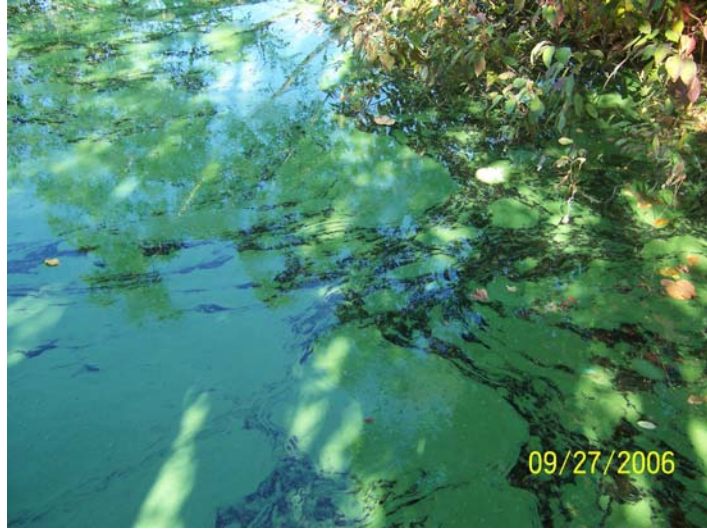
Data Support Photo 2. Algae bloom on Little Pond, Norwalk River watershed.

- Twenty nine out of 30 samples from 4 locations > 0.06 mg/L Total Phosphorus (75th percentile of streams in southwest coastal basin) *
- Route 7 POTW contributes TP to receiving water
- 15% Impervious Cover in watershed support landuse contributions of TP
- Connecticut DEP monitoring data show that urban landuse results in higher TP concentrations (Figure 4)
- Visual observations in the watershed show potential evidence of anthropogenic enrichment (Data Support Photo 2)

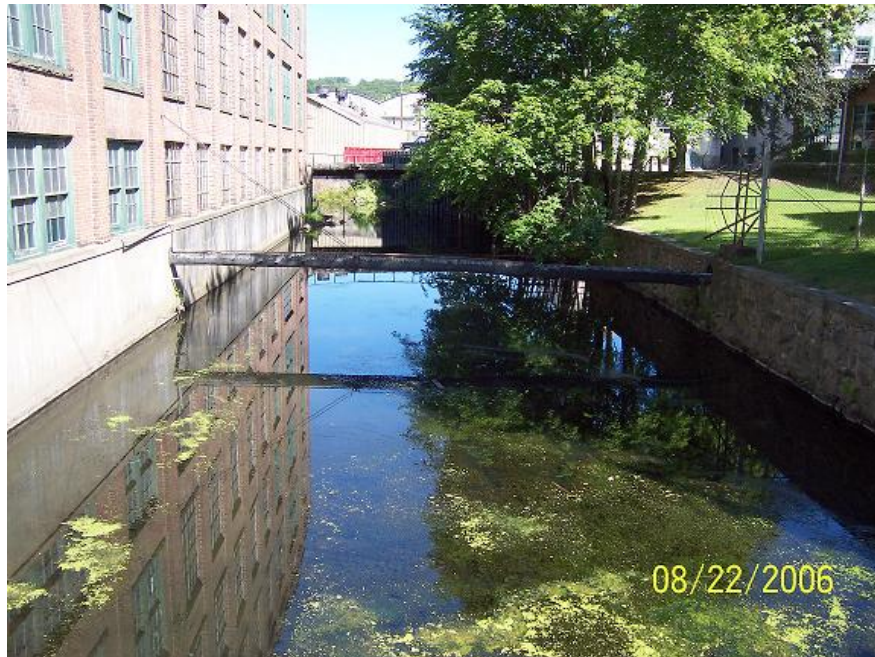
Data Support Photo 3. Norwalk River upstream North Main Street, below Factory Pond.

- Forty two out of 49 samples from 5 locations > 0.06 mg/L Total Phosphorus (75th percentile of streams in southwest coastal basin) *
- Georgetown POTW contributes TP to receiving water
- 15 % Impervious Cover in watershed support landuse contributions of TP
- Connecticut DEP monitoring data show that urban landuse results in higher TP concentrations (Figure 4)
- Visual observations of in watershed show evidence of anthropogenic enrichment (Data Support Photo 3 and 4)

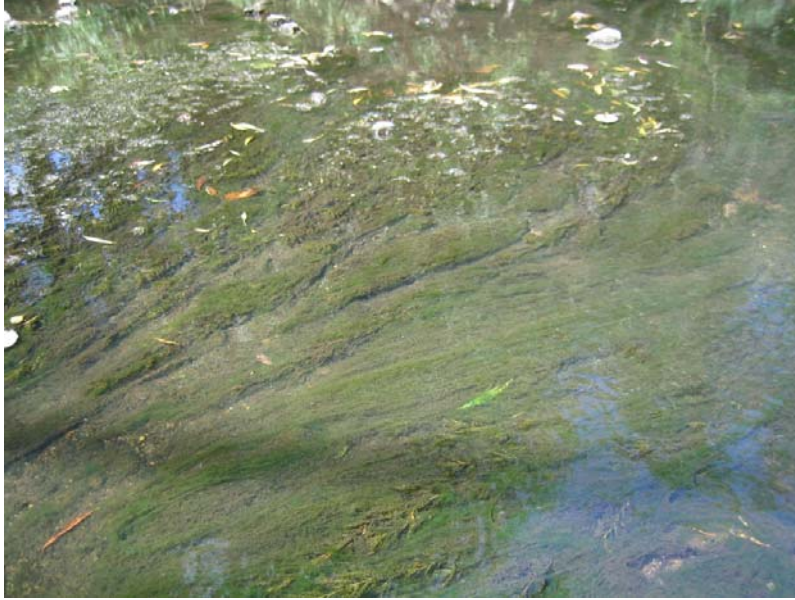
Data Support Photo 4. Norwalk River near Georgetown POTW outfall.

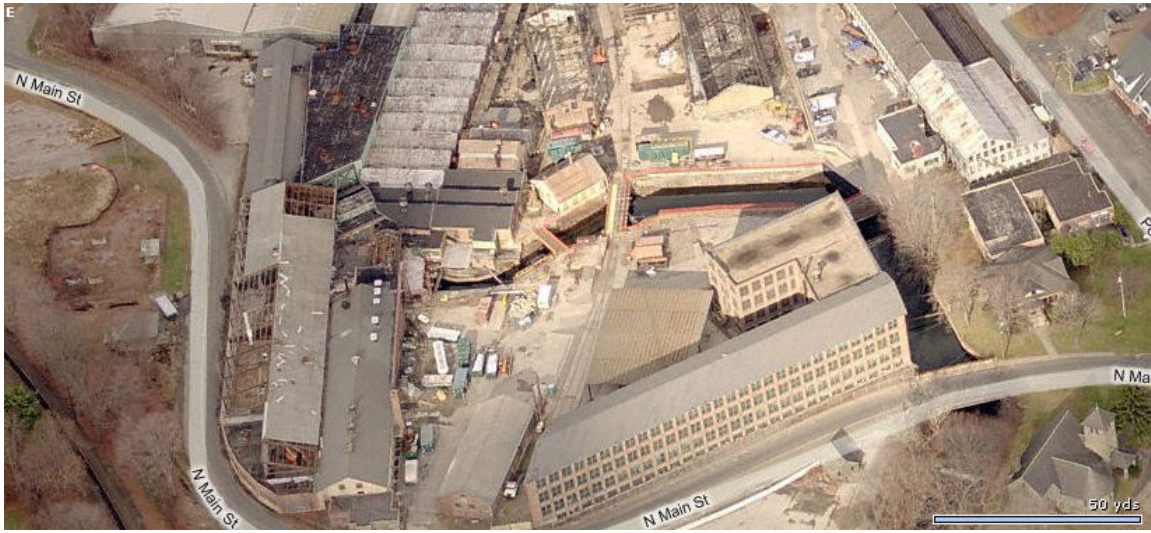
Data Support Photo 5. Norwalk River flowing through former Gilbert and Bennett Facility upstream of North Main Street, Georgetown, Connecticut.

- Three out of 43 samples from 5 locations exceeds 65 $\mu\text{g}/\text{l}$ (acute surface water criterion) for zinc
- 15 % Impervious Cover in watershed support landuse contributions to Zn
- Georgetown POTW contributes Zn to receiving water
- Groundwater sampling shows that zinc is the metal that most frequently exceeds Connecticut's Surface Water Protection Criteria from former Gilbert & Bennett that is undergoing remediation ⁷ (Data Support Photo 5)

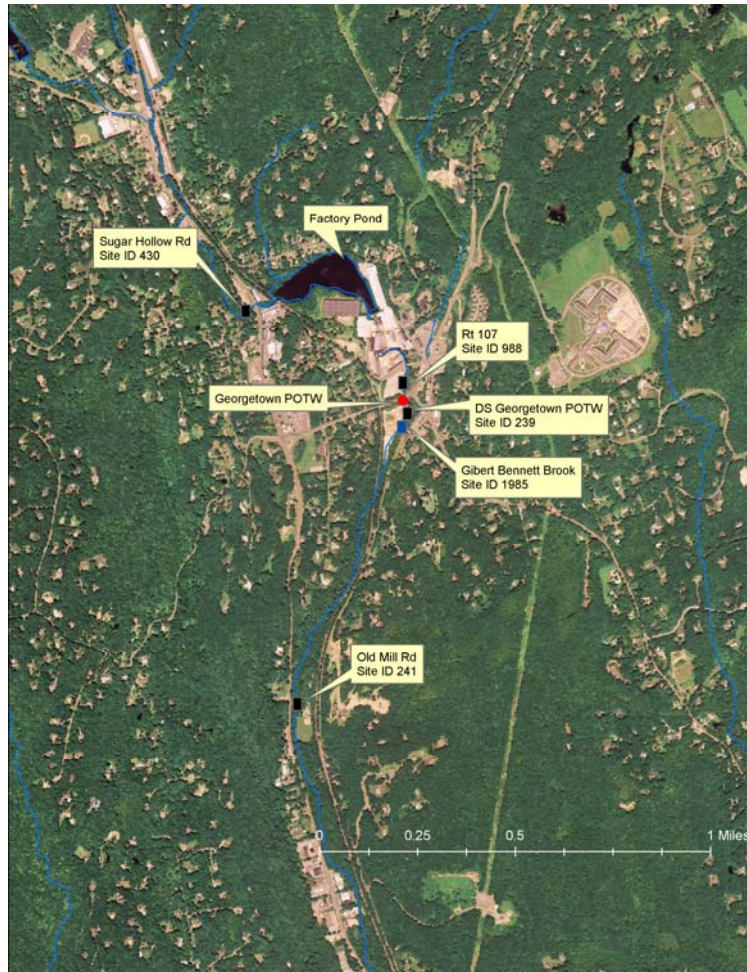
Figure 9. Map showing locations of monitoring locations in the Georgetown section of the Norwalk River. Monitoring sites are shown as black squares, the Georgetown sewage treatment plant is shown as a **red circle**, and tributaries are shown as a **blue square**.

- Median August temperatures from continuous data loggers >20 C with extremes exceeding 25C⁵
- 15 % Impervious Cover in watershed supports episodic fluctuations in ambient stream temperatures
- Factory Pond Dam creates an impoundment on the Norwalk River that contributes to increasing stream temperatures (Figure 9,10; Table 2).
- Georgetown POTW contributes to increasing stream temperatures (Figure 9,10; Table 2).

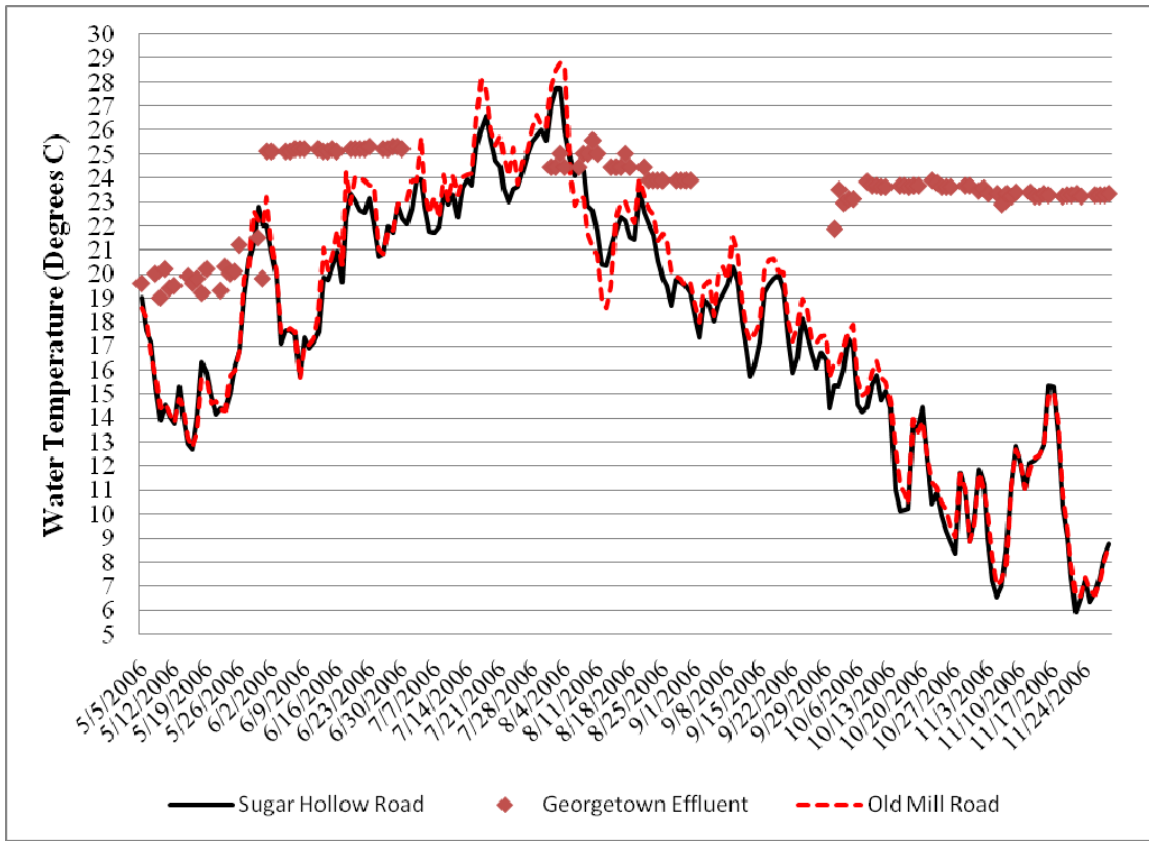
Figure 10. Average daily water temperature from monitoring locations in the Norwalk River upstream (Sugar Hollow Road) and downstream (Old Mill Road) of the Georgetown sewage treatment plant. Norwalk River temperatures were collected using Hobo continuous data loggers deployed by CTDEP and average daily effluent temperatures for Georgetown were obtained from facility monthly operating reports.

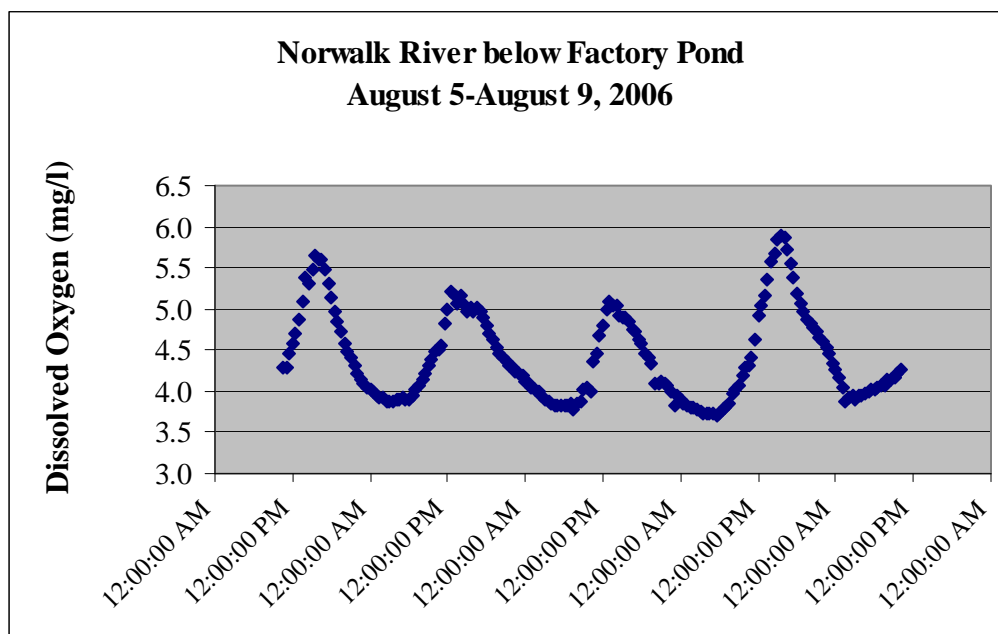
Figure 12. Dissolved oxygen profile in the Norwalk River below Factory Pond taken from August 5-9, 2006 with YSI Sonde.

- 15 % Impervious Cover in watershed support landuse contributions to decreasing dissolved oxygen in Norwalk River
- Continuous YSI monitoring data collected by Harbor Watch River Watch in August 2006 shows dissolved oxygen below 5.0 mg/L (Figure 12)
- Elevated total phosphorus⁵ concentrations create optimal conditions for aquatic plant growth and could exacerbate dissolved oxygen when plants die and decay

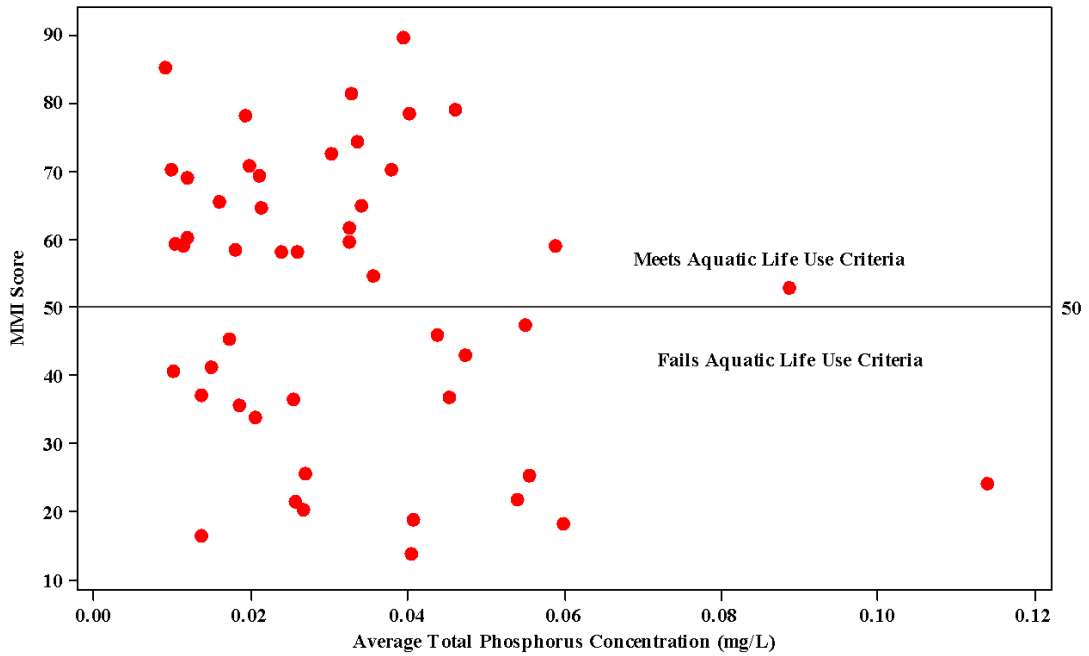
Figure 15. Relationship between average total phosphorus concentration and macroinvertebrate multimetric index score (MMI) from 48 streams in Connecticut. MMI is one of the factors used to determine aquatic life support designated use. A $MMI > 50$ indicates a site meets minimum aquatic life use criteria and < 50 indicates a site fails minimum aquatic life use criteria.
