Harbor Watch | 2017

# Harbor Health Study: 2017

Demersal fish study in Norwalk Harbor and dissolved oxygen studies in Stamford Harbor, Five Mile Harbor, Norwalk Harbor, Saugatuck Harbor, Lewis Gut, and New Haven Harbor

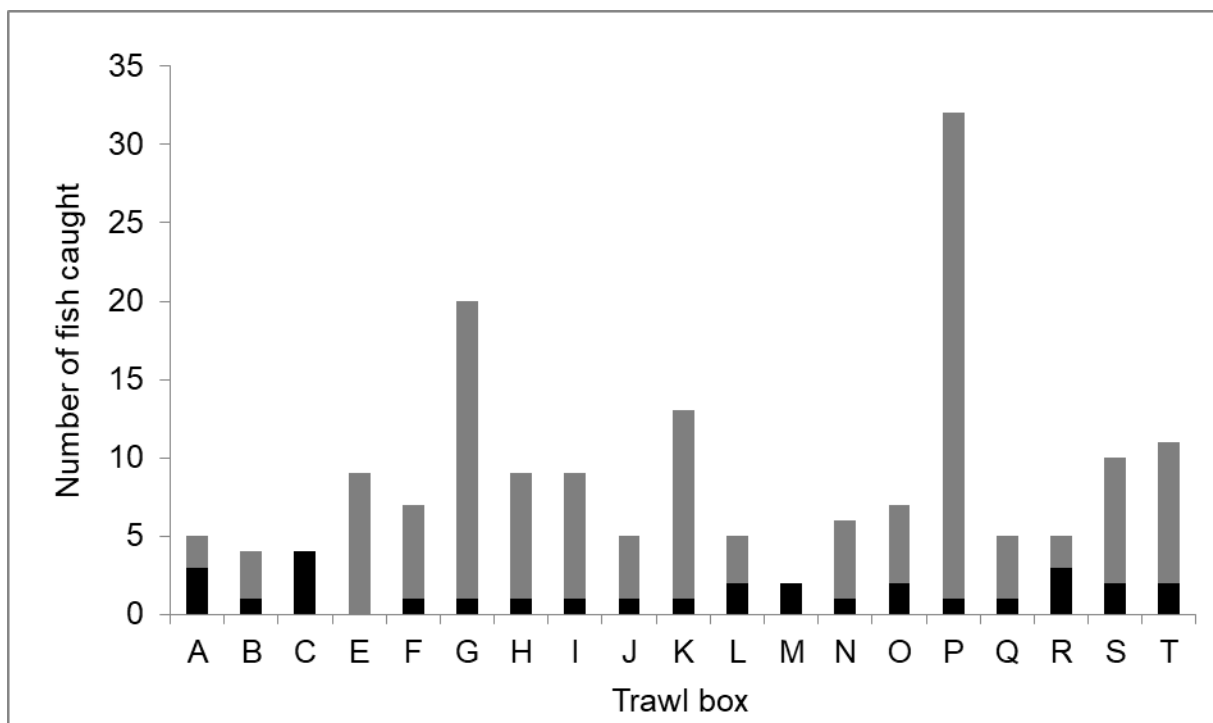
**Figure 1.3.** Number of fish caught and trawls with empty nets in each box in Norwalk Harbor, May through October 2017. Common names for the species codes are listed in Table 1.1.

The 2017 season had the second lowest number of fish per trawl ever observed in this study for winter flounder. The only season with a lower number of fish per trawl was in 2002, but this is likely an artifact resulting from the fact that very few trawls were conducted. There were only 11 winter flounder caught in total in 2017 and one of these was believed to be a one year old fish and not a young-of-the-year fish as are typically observed. In 2017, cunner was the species observed most frequently, with 0.42 fish per trawl observed. However, the majority of this observed abundance resulted from one trawl where 24 fish were observed in box "P" (Figure 1.3).

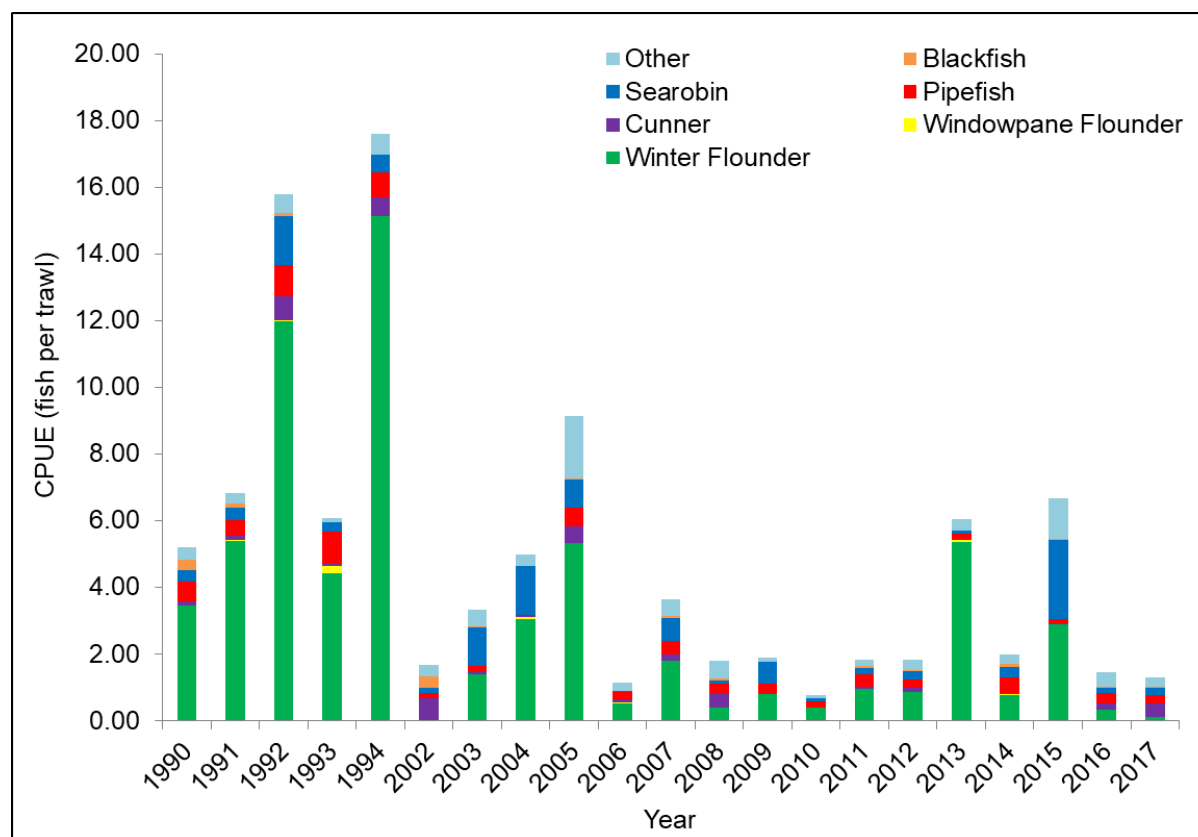
**Figure 1.4.** Catch per trawl from 1990 to 2017 in Norwalk Harbor.

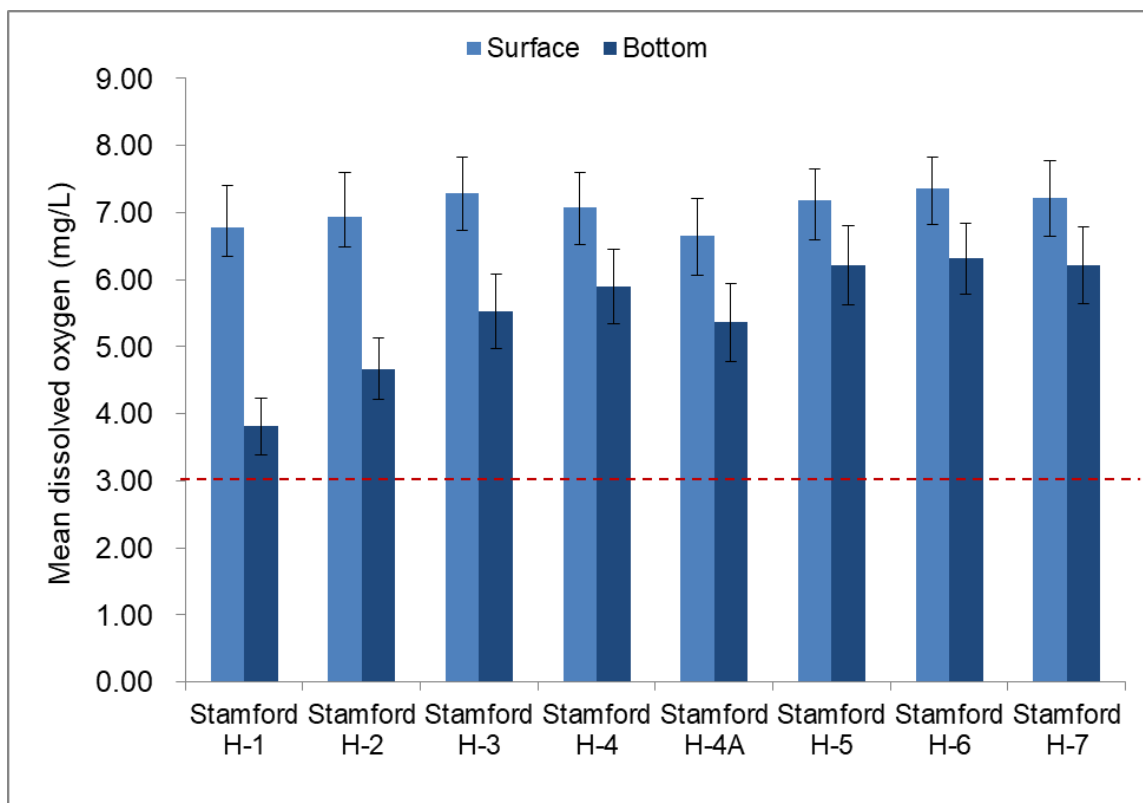
**Figure 2.A.3.** Mean dissolved oxygen concentrations at the surface and bottom at each sampling station in Stamford Harbor. Error bars represent standard error. Dissolved oxygen values below the dashed line indicate hypoxic conditions (less than 3mg/L).

Profiles of the water column were taken at 8 sites along the length of the Harbor (Figure 2.A.2, Table 2.A.1). Sampling occurred on 8 days during the monitoring season. Mean dissolved oxygen values in Stamford Harbor ranged from a minimum of 3.81 mg/L on the bottom at Stamford H-1 to a maximum of 7.35 mg/L on the surface at Stamford H-6 (Figure 2.A.3). There were wider differences observed between the surface and bottom dissolved oxygen levels in the upper end of the west channel than the east channel and lower half of the harbor (Figure 2.A.3). Over the course of the monitoring season, there was a general downward trend in dissolved oxygen values at both the surface and the bottom as the summer progressed. Only three individual bottom readings in the upper end of the west channel dropped below 3 mg/L in August on 8/9 and 8/22 (Figure 2.A.4).

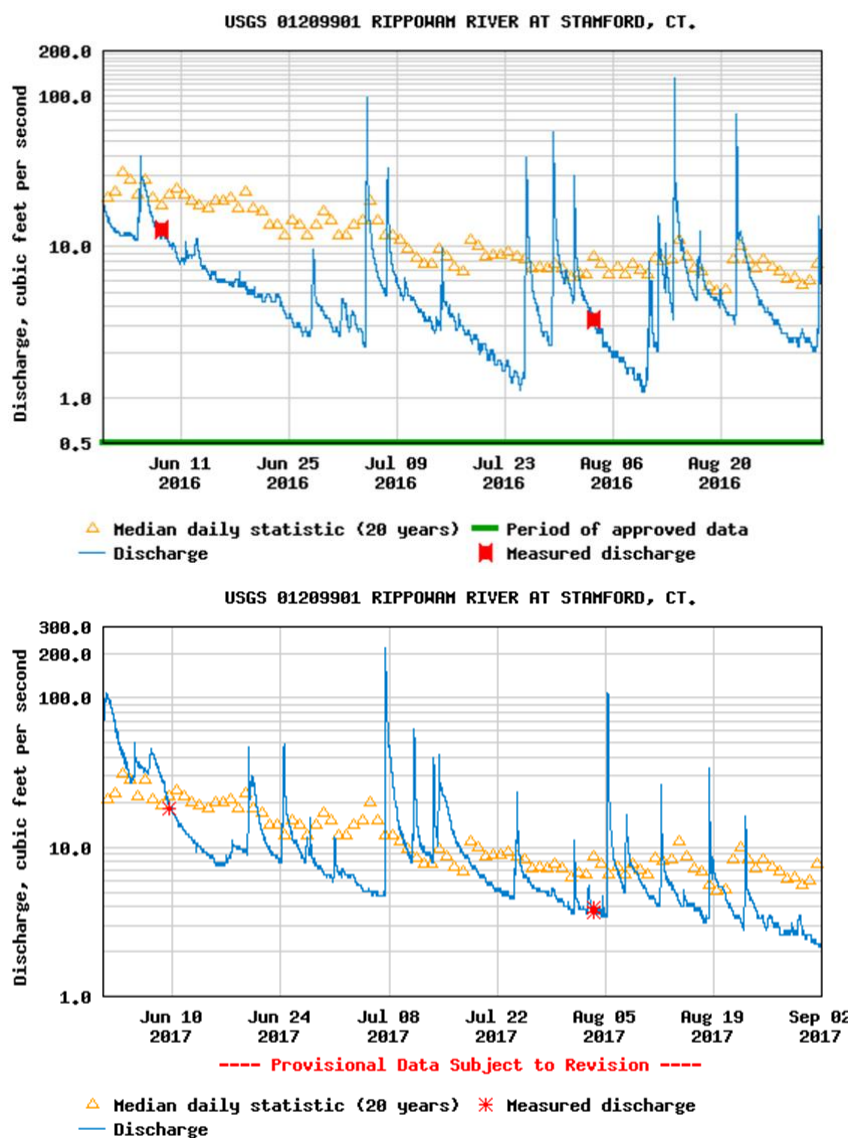
**Figure 2.A.6.** USGS flow data in feet<sup>3</sup>/s for the period of June 1st through August 31st for the 2016 and 2017 respectively for the Rippowam River in Stamford, CT (Graphs courtesy of the U.S. Geological Survey).

The figures below illustrate discharge in cubic feet per second recorded at the United States Geological Survey monitoring station on the Rippowam River in Stamford, CT. Yellow triangles represent the daily median value over the last 20 years, and the blue line represents the recorded discharge for a particular date. In the summer of 2016, discharge was observed to be below historic norms, dipping as low as approximately 1 ft<sup>3</sup>/s twice in July and August. For the same time period in 2017, discharge appeared to be closer to historic norms, only dropping to a minimum of approximately 2 ft<sup>3</sup>/s at the beginning of September. These figures indicate that flow in the Rippowam River, which discharges to the west branch of the harbor, may have been slightly greater in 2017 than 2016.

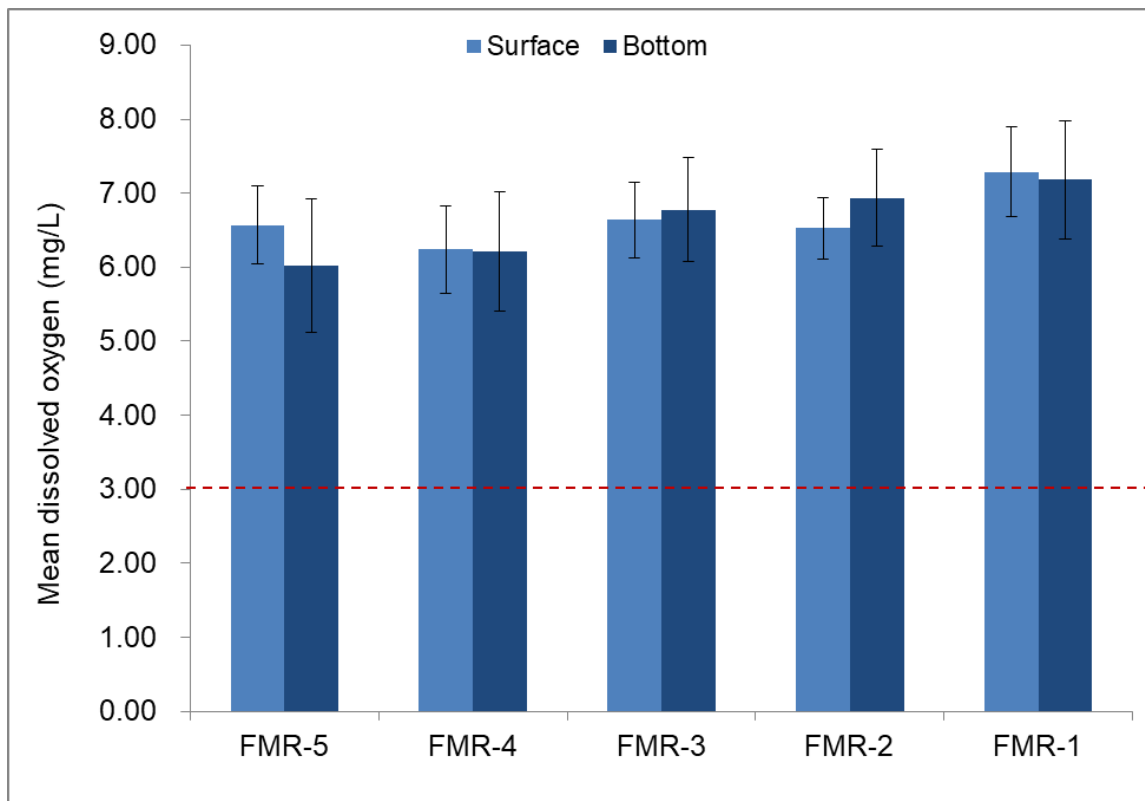
**Figure 2.B.2.** Mean dissolved oxygen concentrations at the surface and bottom at each sampling station in Five Mile River Harbor. Error bars represent standard error. Values below the red dashed line indicate hypoxic conditions (less than 3mg/L).

Profiles of the water column were taken at 5 sites along the length of the Harbor (Figure 2.B.1, Table 2.B.1). Monitoring occurred on 8 days during the monitoring season. Surface and bottom dissolved oxygen concentrations at all sites had mean values above 6 mg/L (Figure 2.B.2). For comparison, during the 2016 season the observed dissolved oxygen mean for station FMRH-5 was 4.6 mg/L at the bottom and 5.3 mg/L at the surface (Figure 2.B.4). The average dissolved oxygen at the other four stations ranged from 5.2 mg/L to 5.8 mg/L in 2016 at the bottom. The average surface dissolved oxygen in 2016 at stations FMRH-4 to FMRH-2 exceeded 6 mg/L with only station FMR-1 exceeding 7 mg/L (Crosby et al., 2017a).

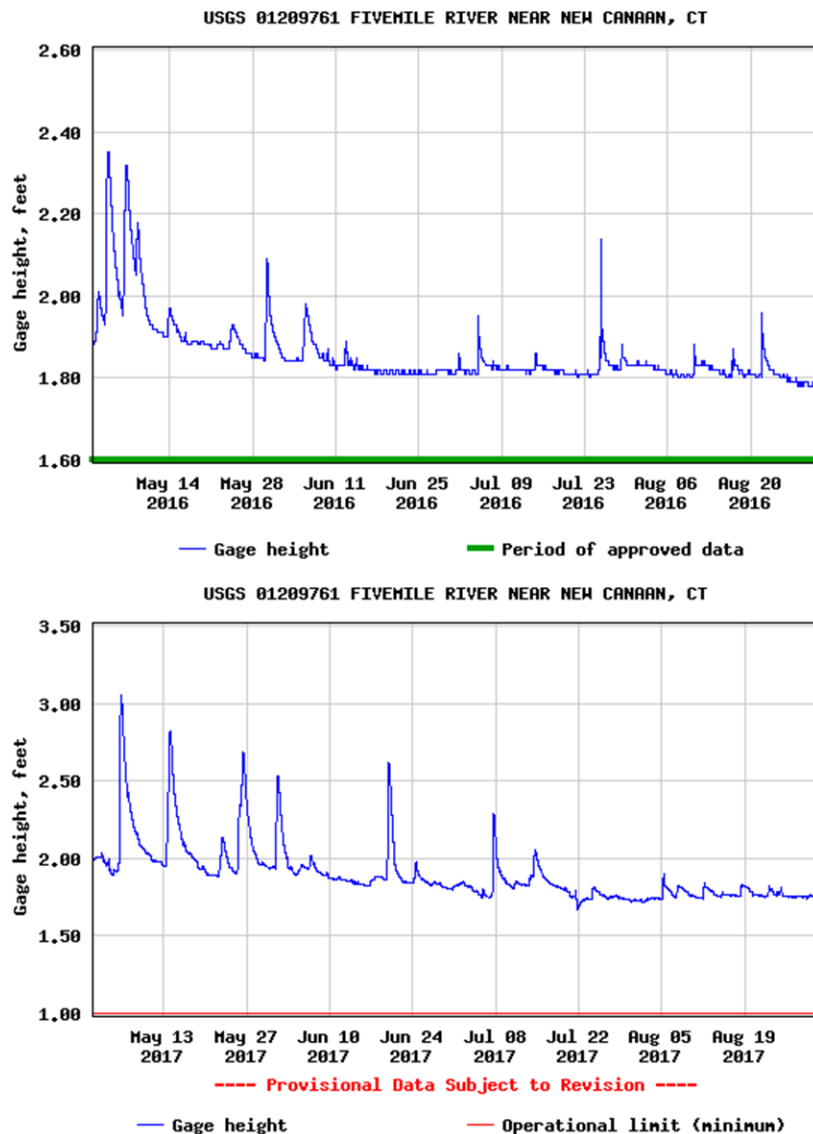
**Figure 2.B.5.** USGS stream gauge height for the period of May 1st through August 31st for the 2016 and 2017 respectively for the Five Mile River in New Canaan, CT (Graphs courtesy of the U.S. Geological Survey).

One factor contributing to improved dissolved oxygen levels in 2017 could be an increase of fresh water flow from the Five Mile River based on stream gauge heights (Figure 2.B.6). A second factor could be atypically cool weather conditions. Ambient air temperatures dropped as much as 6 °C in late July (Appendix 1.1, “Historical Weather”). Water temperature at the 5 stations from July to August had lower temperatures relative to similar sampling dates in 2016 and consequently more dissolved oxygen could have mixed into the surface layers (Figure 2.B.2, Figure 2.B.3, Appendix 2.2). Nevertheless, dissolved oxygen concentrations decreased from June to August (Figure 2.B.3). Sampling of this harbor was not conducted in September, but dissolved oxygen concentrations increased with the cooler weather in Norwalk and Saugatuck Harbors which had longer survey periods (Section C and D of this report).

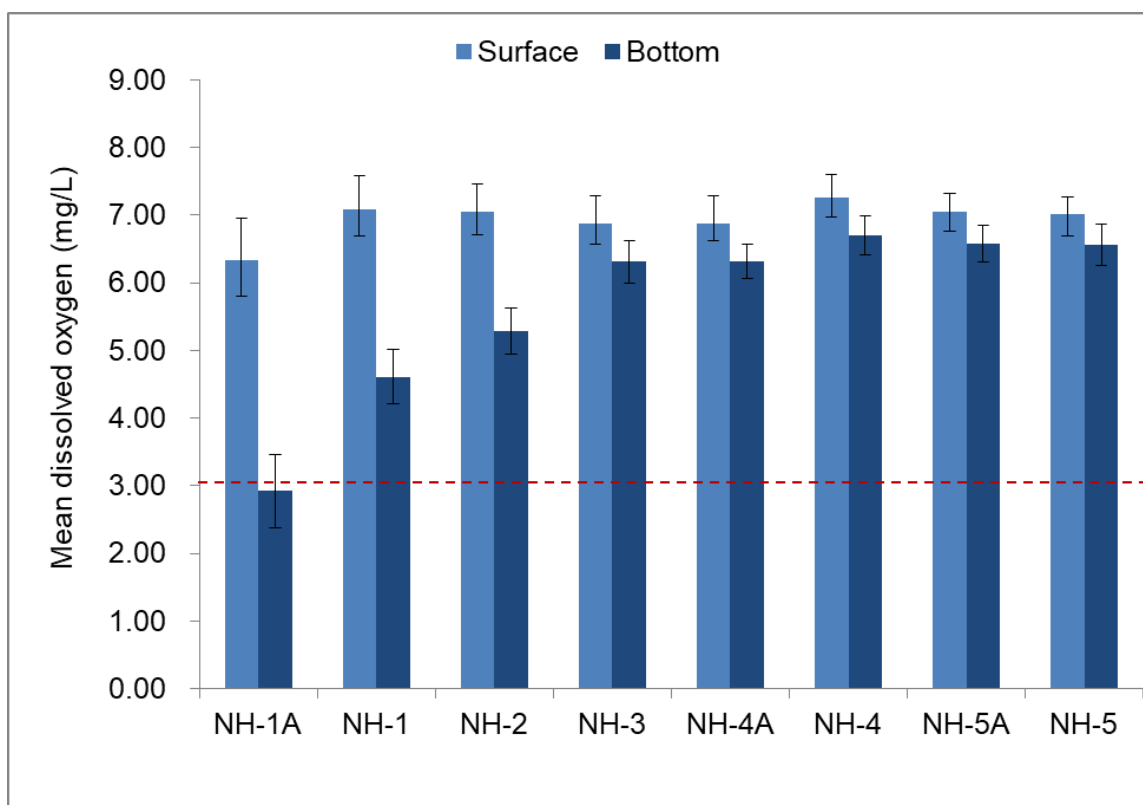
**Figure 2.C.3.** Mean dissolved oxygen concentrations at the surface and bottom at each sampling station in Norwalk Harbor. Error bars represent standard error. Values below the red dashed line represent hypoxic conditions (less than 3 mg/L).

Profiles were taken in the inner harbor at 8 sampling stations. Sampling occurred 20 times between May and October 2017. Mean dissolved oxygen concentrations ranged from a minimum of 2.92 mg/L at the bottom at station NH-1A to a maximum of 7.27 mg/L at the surface at station NH-4 (Figure 2.C.3). Wide ranges in dissolved oxygen concentrations at the surface and bottom were observed in most of the upstream sampling locations (Figure 2.C.3, Figure 2.C.4). In the sampling locations further seaward in the harbor, the difference in concentrations was lower, presumably from the wider area of the harbor and increased mixing reducing stratification. The upper 3 stations, NH-1A, NH-1 and NH-2 likely had a highly stratified water column throughout the season driven by a steady flow of fresh water entering the harbor from the Norwalk River (Figure 2.C.8). This stratification led to station NH-1A consistently being the site with the most impaired water in the harbor for dissolved oxygen. As the fresh water moved seaward, mixing increased, in particular near station NH-2 with 18 million gallons per day of treated effluent being discharged from the Norwalk waste water treatment plant (Figure 2.C.2, WPCA Norwalk). The 3 upper harbor sites have historically experienced prolonged periods of hypoxia because they have limited flushing and are often exposed to a variety of inputs from storm drain networks and anthropogenic waste on the harbor bottom. Water columns at stations south of NH-4A exhibited less stratification as the fresh water became increasingly diluted. Typically, dissolved oxygen concentrations tend to decrease when air temperatures rise as the summer progresses. This year, however, unseasonably cooler weather occurred in late summer, which may have increased surface water cooling especially at night (Appendix 1.1, “Historical Weather”, Appendix 2.3). Cooler surface water can sink and create

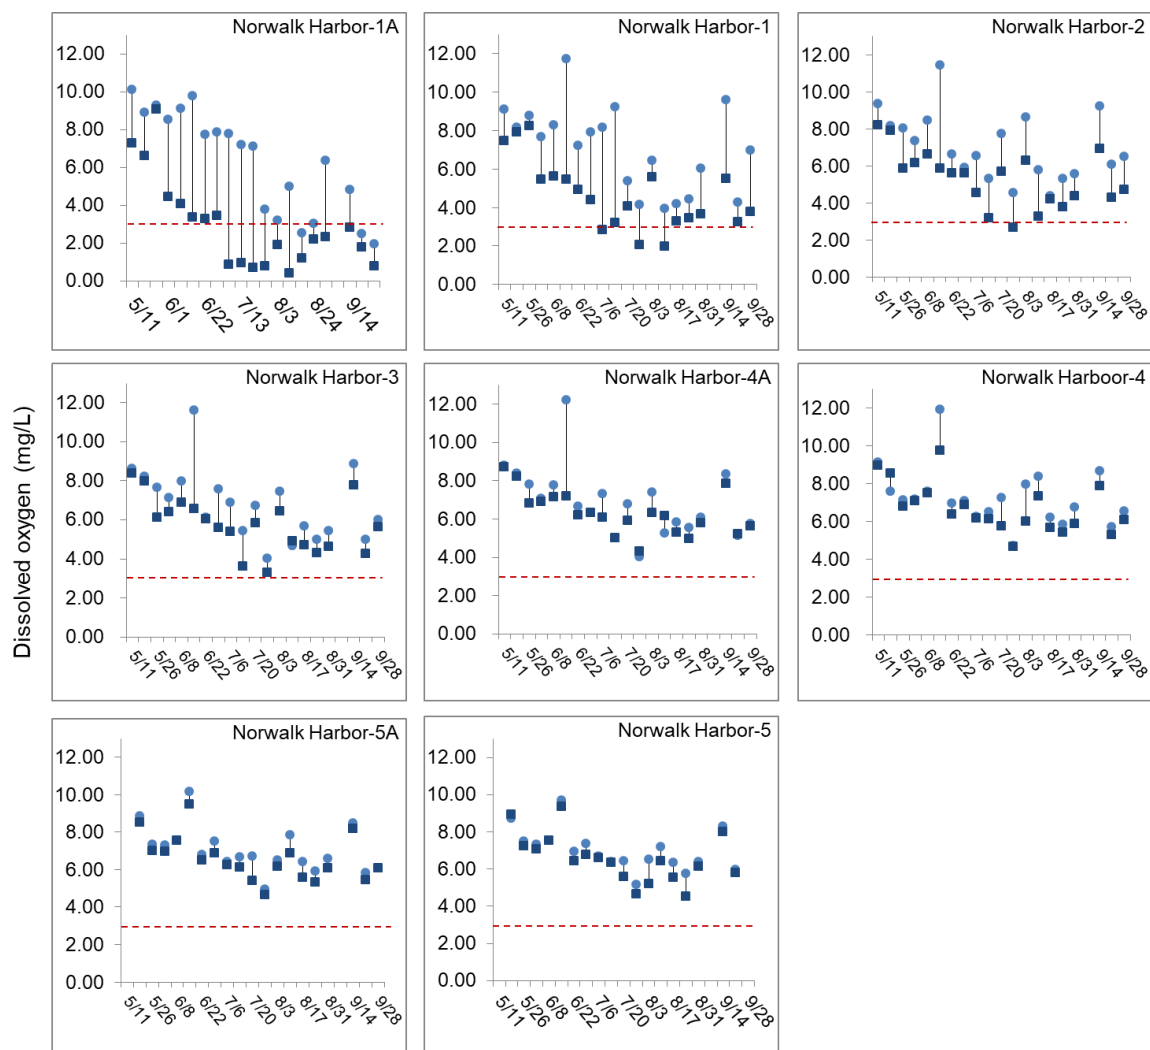
**Figure 2.C.4.** Surface and bottom dissolved oxygen values at each Norwalk Harbor sampling station on each monitoring date during the 2017 season. Circles represent surface dissolved oxygen values and squares represent bottom dissolved oxygen values. Values below the red dashed line represent hypoxic conditions (less than 3 mg/L).

Throughout the monitoring season, dissolved oxygen values decreased as the summer progressed (Figure 2.C.4). Exceptions to this were 6/16 and 9/19 where both surface and bottom temperatures were elevated, possibly due to photosynthetic activity. A dinoflagellate bloom, *Prorocentrum micans*, occurred in June for approximately two weeks and was visible as large brown clouds in the harbor waters. Samples confirming the species present were collected by Richard Harris and identified by Dr. Gary Wikfors at the NOAA laboratory in Milford, CT. The second observed event was a bloom of an unidentified species which only persisted for several days in early September.

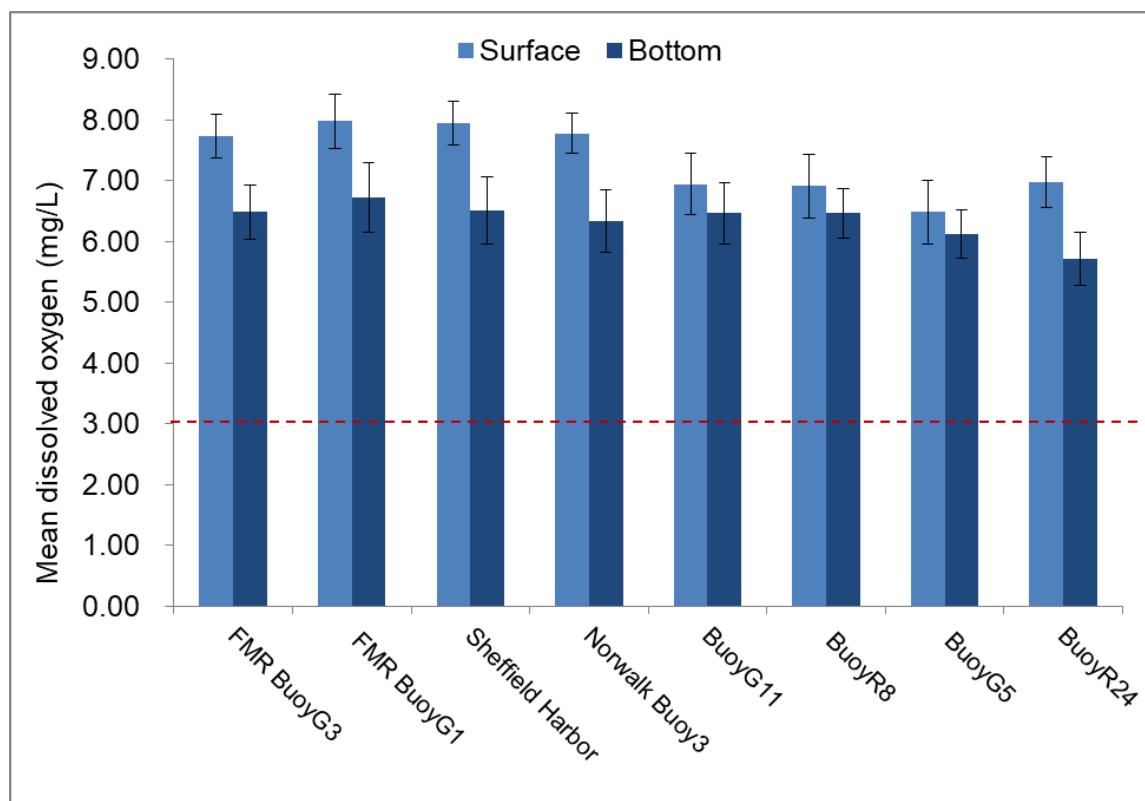
**Figure 2.C.5.** Mean dissolved oxygen concentrations at the surface and bottom at each sampling station in the Outer Norwalk Harbor with sampling conducted during the evening. Error bars represent standard error. Values below the red dashed line represent hypoxic conditions (less than 3 mg/L).

Profiles in the outer harbor were conducted on 7 days at a subset of 8 sampling locations each day by Coast Guard Flotilla 72 members. Dissolved oxygen levels observed in this area can be indicative of whether dissolved oxygen-impaired water may enter the harbor from the east or west between the Norwalk Islands and the mainland. It is important to note that the data collected for the outer harbor sites was collected in the evenings rather than the early morning. Mean bottom dissolved oxygen values at all stations except station R24 exceeded 6.0 mg/L. All mean surface dissolved oxygen values with the exception of station Buoy G5 met or exceeded 7 mg/L (Figure 2.C.5, Figure 2.C.6). Results were similar to what was observed at these same stations in 2016. Water quality in this area remained good during the monitoring period with only a slight decline in dissolved oxygen into August (Figure 2.C.6). All dissolved

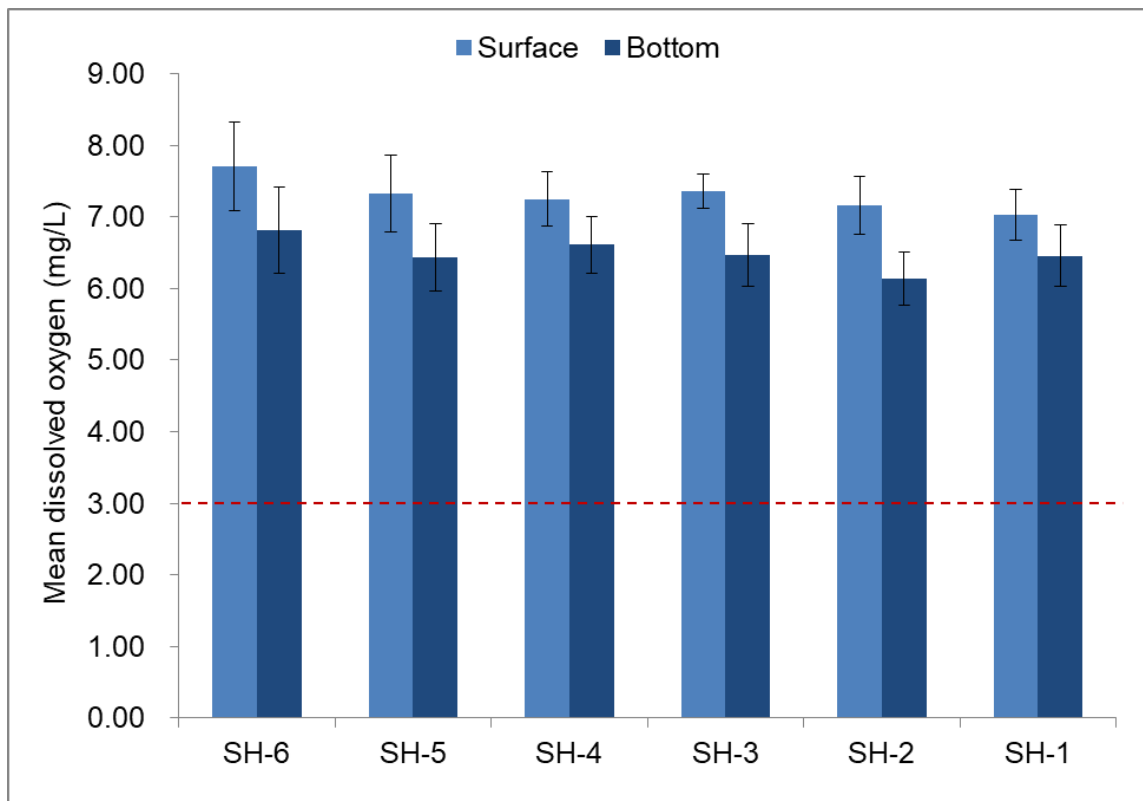
**Figure 2.D.3.** Mean dissolved oxygen concentrations at the surface and bottom at each sampling station in Saugatuck Harbor. Error bars represent standard error. Values below the red dashed line represent hypoxic conditions (less than 3 mg/L).

Profiles were taken at 6 stations on 8 sampling days from June to September 2017. Mean dissolved oxygen levels ranged between 6.13 mg/L at the bottom of station SH-2 to 7.70 mg/L at the surface of station SH-6 (Figure 2.D.3). All individual readings at each station were recorded to be above 3 mg/L (Figure 2.D.4). Water quality observed during 2017 in Saugatuck Harbor was improved relative to 2016 (Crosby et al., 2017a). Improvement in the Saugatuck water quality may be related to greater rainfall in the Saugatuck River's watershed in 2017, which could have resulted in greater freshwater volume flowing in the Saugatuck River and ultimately flowing into the estuary where it may have served to increase and aid flushing efficiency. Unseasonably cool weather during late summer may also have promoted better water quality by driving downwelling in cooler surface waters and allowing more dissolved oxygen to enter the surface waters (Figure 2.D.4). Rainfall amounts for 2017 were marginally higher than 2016 as recorded at the Norwalk Health Department for the period of May through September ("Norwalk Health Department Raingauge").

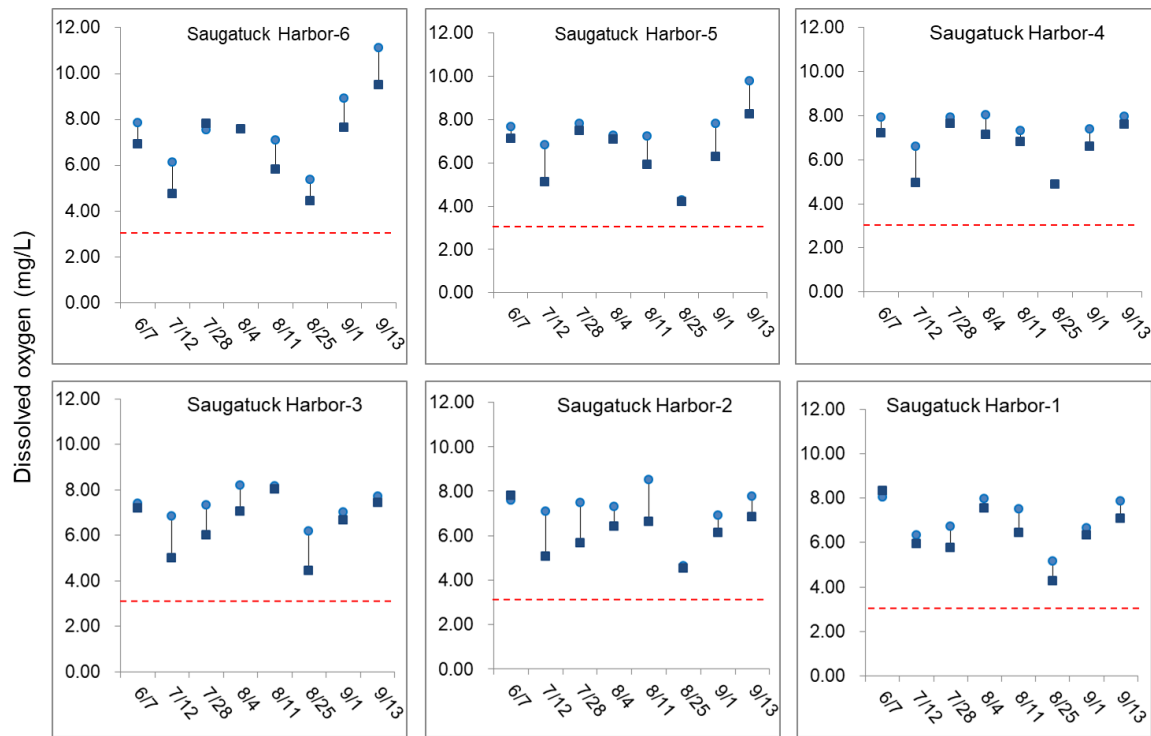
**Figure 2.D.4.** Surface and bottom dissolved oxygen values at each Saugatuck Harbor sampling station on each monitoring date during the 2017 season. Circles represent surface dissolved oxygen values and squares represent bottom dissolved oxygen values. Values below the red dashed line represent hypoxic conditions (less than 3 mg/L).

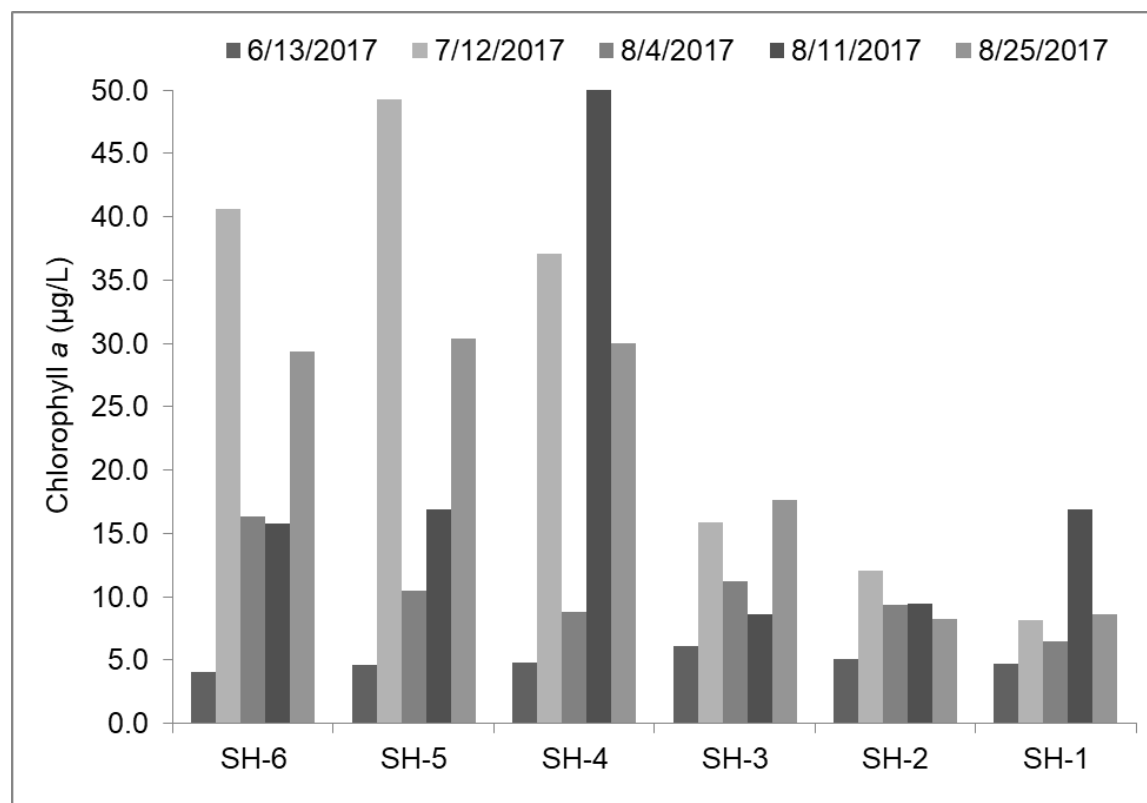
**Figure 2.D.5.** Average chlorophyll *a* values in Saugatuck Harbor.

Chlorophyll *a* sampling was conducted during 5 monitoring events on 6/13, 7/12, 8/4, 8/11, and 8/25. A large amount of microalgae was observed in particular at stations SH-6, SH-5, and SH-4 (Figure 2.D.5). The river's fresh water input and storm drain outfalls served as likely sources of nutrients in close proximity to these three sites in particular, likely facilitating the high productivity observed. Two large blooms encompassing the area around these top three stations occurred on 7/12 and 8/25 (Figure 2.D.5). The first of these blooms was observed immediately after a rainfall event of 0.87 inches which may have accelerated the bloom by flushing a renewed supply of nutrients into the estuary ("Norwalk Health Department Raingauge"). The second major bloom on 8/25 was observed 2 days after a rainfall event of 1.28 inches with a similar result. A third bloom was also observed only at station SH-4 on 8/11, but was not coupled with a rain event as the others had been (Figure 2.D.5). Overall, the chlorophyll *a* data for the 2017 season was similar to what was observed during the 2016 monitoring season (Crosby et al., 2017a). This harbor can thus be classified as highly eutrophic ( $> 20 \mu\text{g/L}$ ,  $\leq 60 \mu\text{g/L}$ ) for the 3 northern stations and medium eutrophic ( $> 5 \mu\text{g/L}$ ,  $\leq 20 \mu\text{g/L}$ ) for the lower 3 stations based on the Bricker classification system (Table 2.1, Figure 2.D.5).
