# HARBOR HEALTH STUDY

# Harbor Health Study: 2018

Demersal fish study in Norwalk Harbor and dissolved oxygen studies in Stamford Harbor, Five Mile Harbor, Norwalk Harbor, Saugatuck Harbor, Bridgeport Harbor (Johnson's Creek and Lewis Gut sections), and New Haven Harbor (Quinnipiac River section)

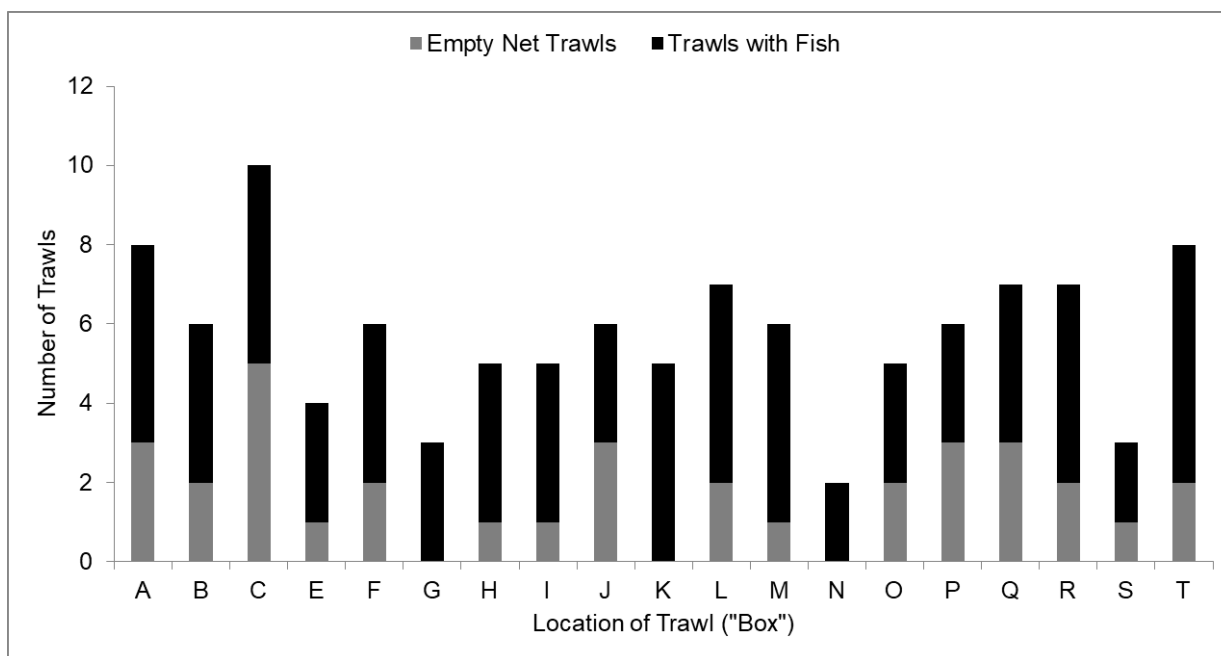
**Figure 1.3.** Number of trawls with fish or without fish in each "box" in Norwalk Harbor from May through October 2018.

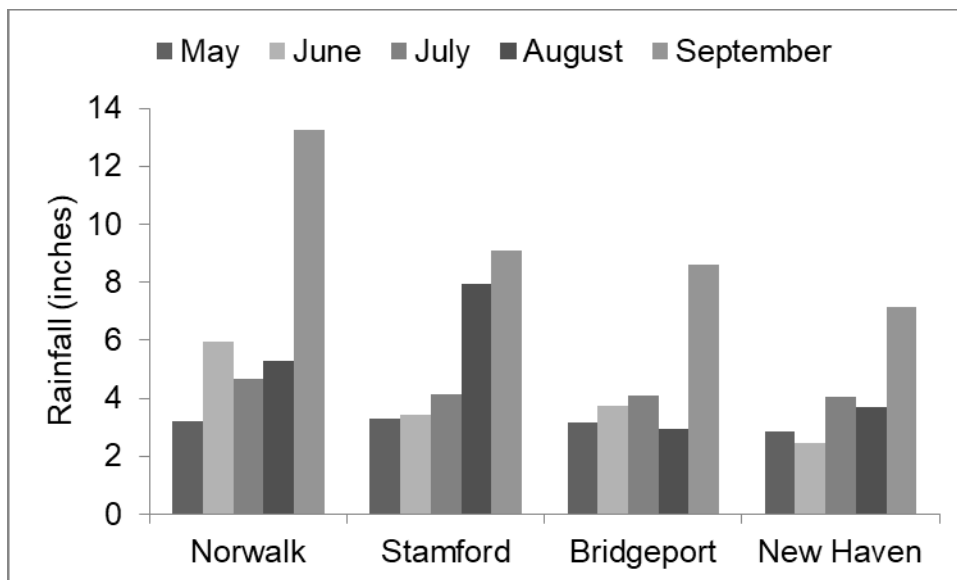
**Figure 2.2.** Rainfall totals for each geographical area monitored. Stamford, Bridgeport and New Haven precipitation data was collected from Wunderground.com while Norwalk precipitation data was collected from the Norwalk Health Department rain gauge.

Rainfall totals varied along the coast. The largest amount of rainfall fell during September averaging 9.52 inches of rain with the smallest accumulation in May averaging 3.11 inches based on data from four rain gauges across the coast (Figure 2.2, Weather Underground Historical Weather, Norwalk Health Department Raingauge). Rainfall totals were highest in the Norwalk area, totaling 32.31 inches from May through September (Weather Underground Historical Weather, Norwalk Health Department Raingauge), nearly 12 inches more than the year prior (Figure 2.3). In 2017, there was a general downward trend during the monitoring season with more rainfall occurring in May, while in 2018 rainfall was highest in all harbors in September. Although rainfall in the harbor area is important, rainfall inland can greatly increase river flow into an estuary. During 2018, rivers feeding the six estuaries were substantially higher at the end of the summer than in 2017; Norwalk River is a good example (Figure 2.C.9).

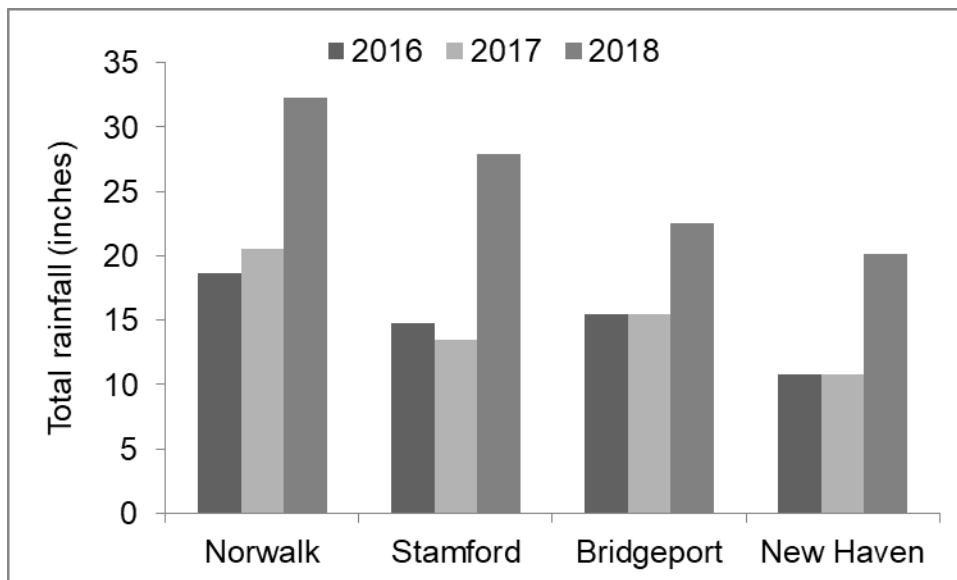
**Figure 2.3.** May through September rainfall totals in 2016, 2017, and 2018 for each geographical area monitored. Stamford, Bridgeport and New Haven precipitation data were collected from Wunderground.com, while Norwalk precipitation data were collected from the Norwalk Health Department rain gauge.

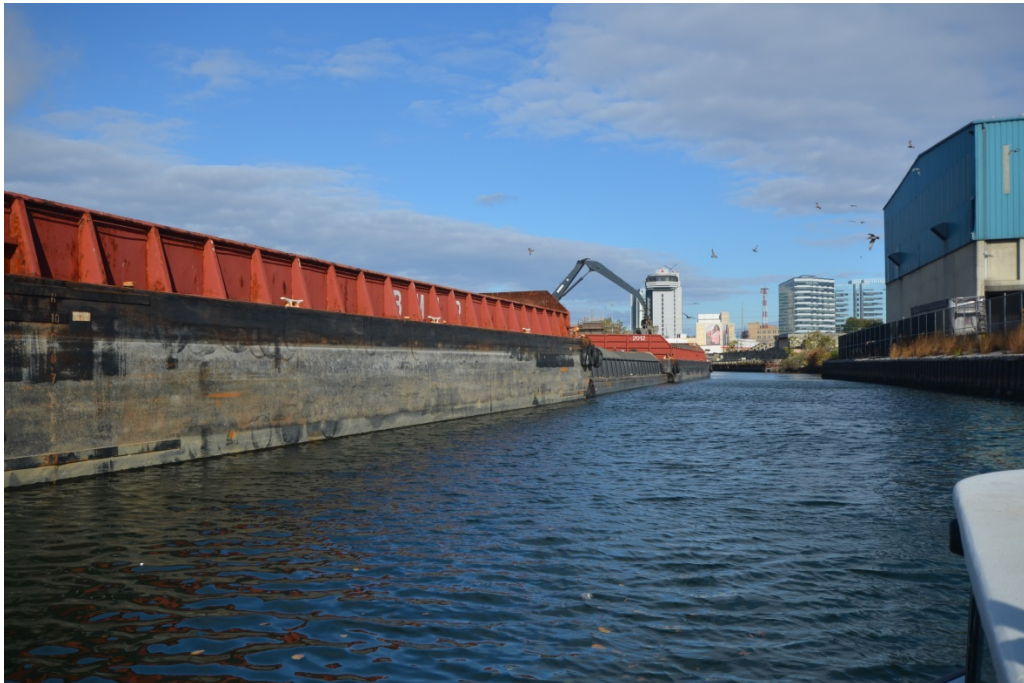
**Figure 2.A.1.** Industrial development and barge traffic on the east branch of Stamford Harbor.

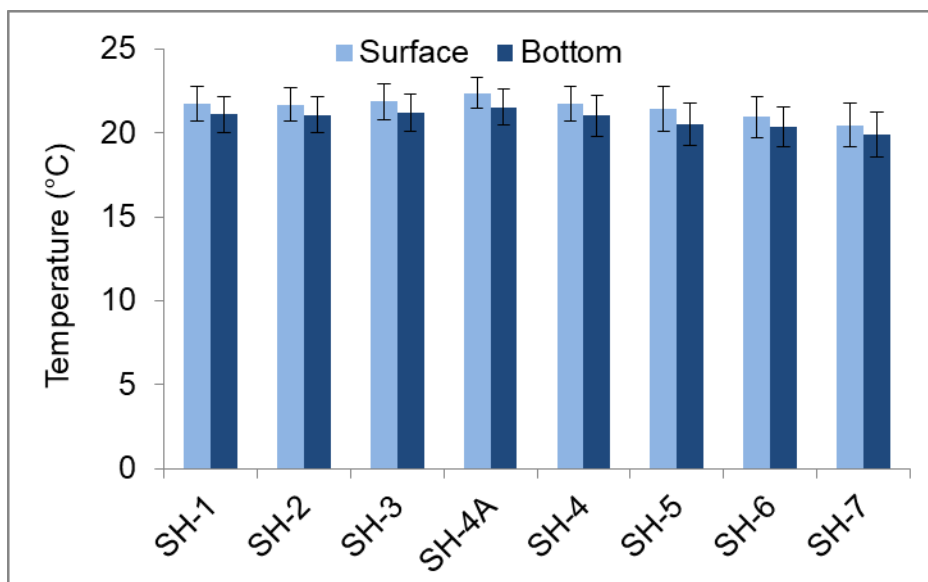
**Figure 2.A.8.** Mean water temperature at the surface and bottom at each sampling station in Stamford Harbor in 2018. Error bars represent standard error.

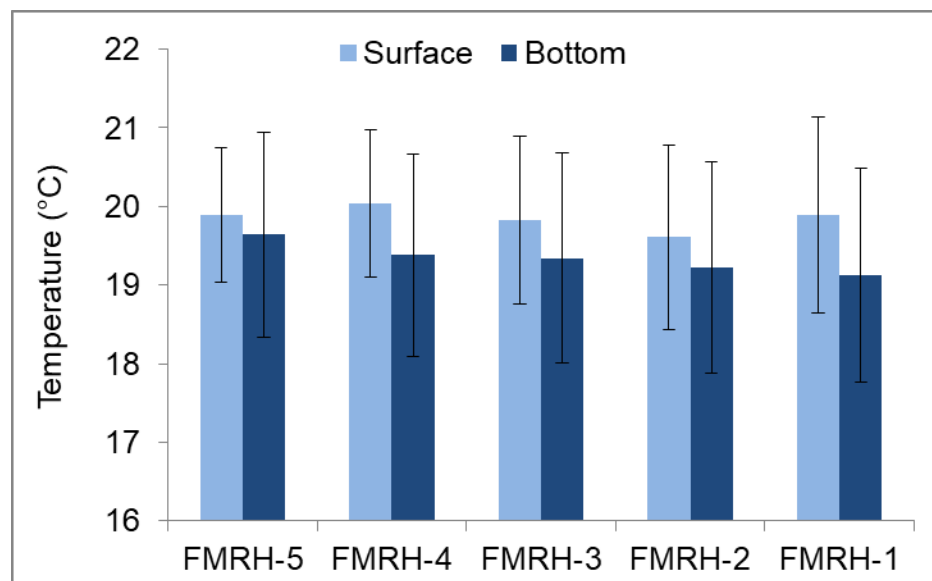
**Figure 2.B.7.** Mean water temperature at the surface and bottom at each sampling station in Five Mile River Harbor in 2018. Error bars represent standard error.

Temperature of the water in Five Mile River Harbor differed less than the dissolved oxygen levels between the surface and the bottom, though on average the marine water at the harbor bottom was cooler at all sites (Figure 2.B.7). Lower salinity observed at the surface in the soundward end of the estuary reflects the impact of riverine input from the north, where the harbor is less well mixed (Figure 2.B.8).

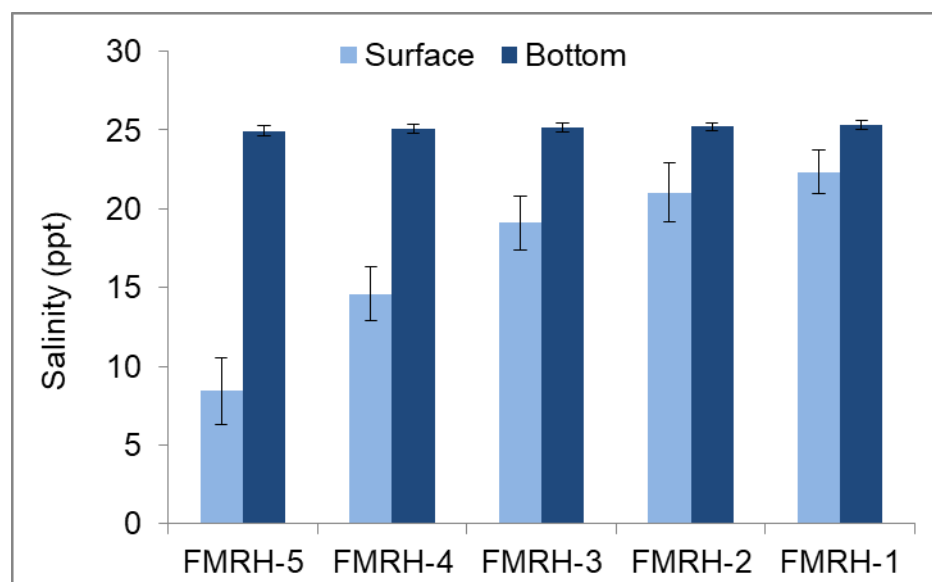
**Figure 2.B.8.** Mean salinity at the surface and bottom at each sampling station in Five Mile River Harbor in 2018. Error bars represent standard error.

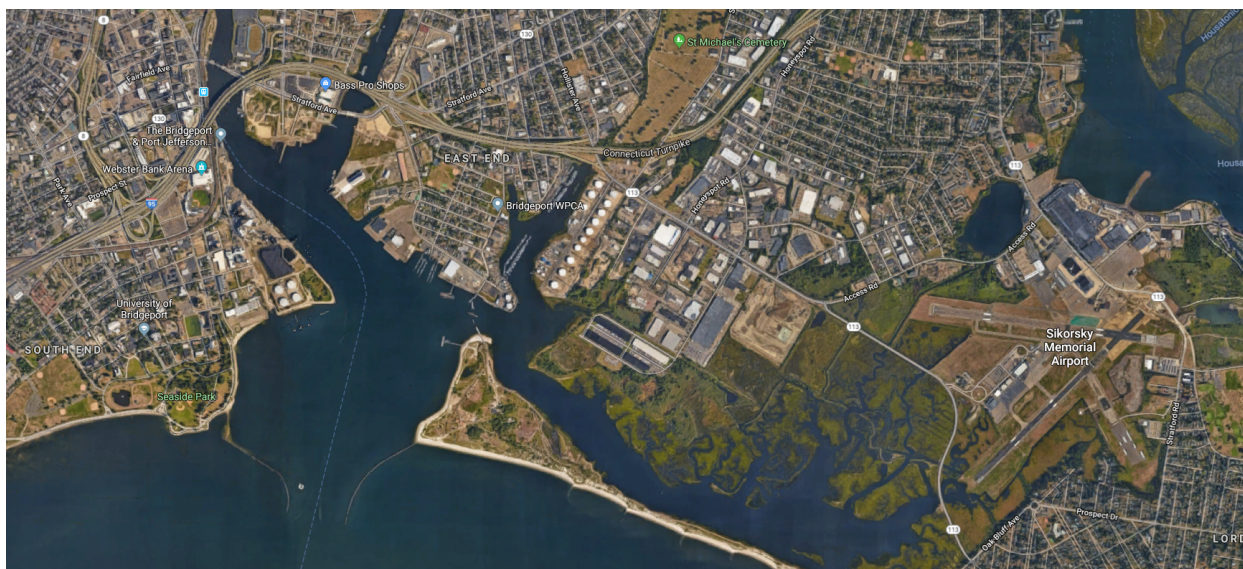
**Figure 2.E.3.** An aerial view of a highly industrialized Johnson's Creek in contrast to the natural setting around Lewis Gut (photo source: Google Maps).

Johnson's Creek is a short  $\frac{1}{4}$  mile channel that starts at the western end of Lewis Gut and extends northward passing a series of petroleum storage tanks and 2 marinas on the east bank up to the I-95 off-ramp. This creek is the terminus of a small stream, Bruce Brook. Johnson's Creek is included in this survey because its waters mix with those of Lewis Gut during tidal cycles (Figure 2.E.1). The 2 water bodies present a significant contrast in terms of water quality. On the one hand, Lewis Gut possesses all the features of an environmentally sound embayment that is surrounded by a natural shoreline. As an added benefit, the bordering extensive wetlands serve as a system to improve water quality. On the other hand, Johnson's Creek is commercially developed and has all the elements of an industrially overcrowded shoreline which receives the discharge from a badly polluted brook (Figure 2.E.3).
