Re: Public Scoping Meeting, Norwalk First Taxing District - Grupes Dam Rehabilitation

It is the position of the NRWA that an Environmental Impact Evaluation of the Grupes Dam Restoration project is necessary as part of the Department of Public Health scoping under the CT Environmental Policy Act. NRWA urges consideration of the following three points not addressed by DEEP Dam Safety in the permitting process.

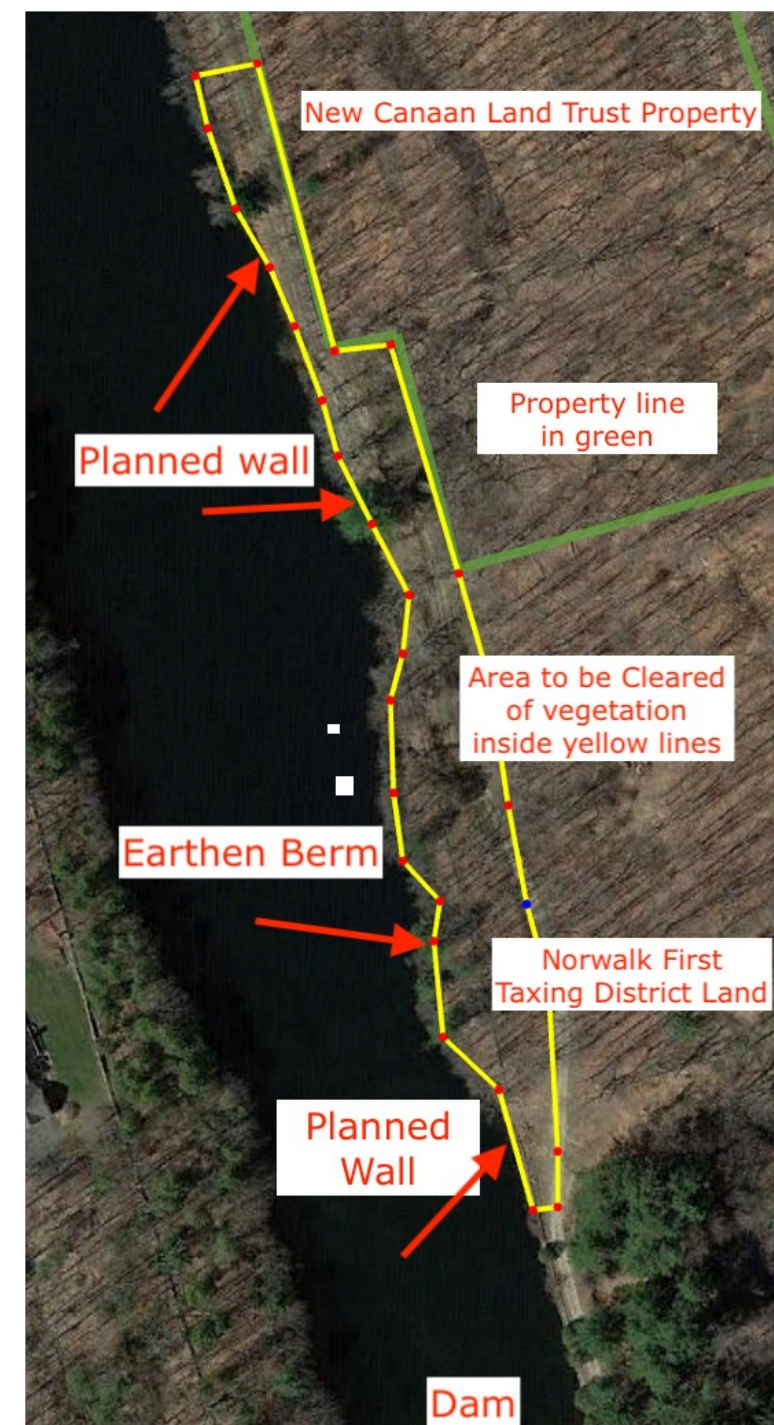
Image 1. The project as proposed requires the removal of riparian buffer vegetation and the erection of walls and berms along 1500 feet of the east side of the reservoir.

The effects of the loss of roughly 400 trees and scores of native shrubs were not considered during the permitting process, as was testified to by the First Taxing District and DEEP.

1. The project as proposed requires the removal of riparian buffer vegetation and the erection of walls and earthen berms contiguously along 1500 feet of the east side of the reservoir. The effects of the loss of roughly 400 trees and scores of native shrubs were not considered during the Dam Safety permitting process, as was testified to by the First Taxing District attorneys and DEEP staff during adjudication. (See image 1 below)

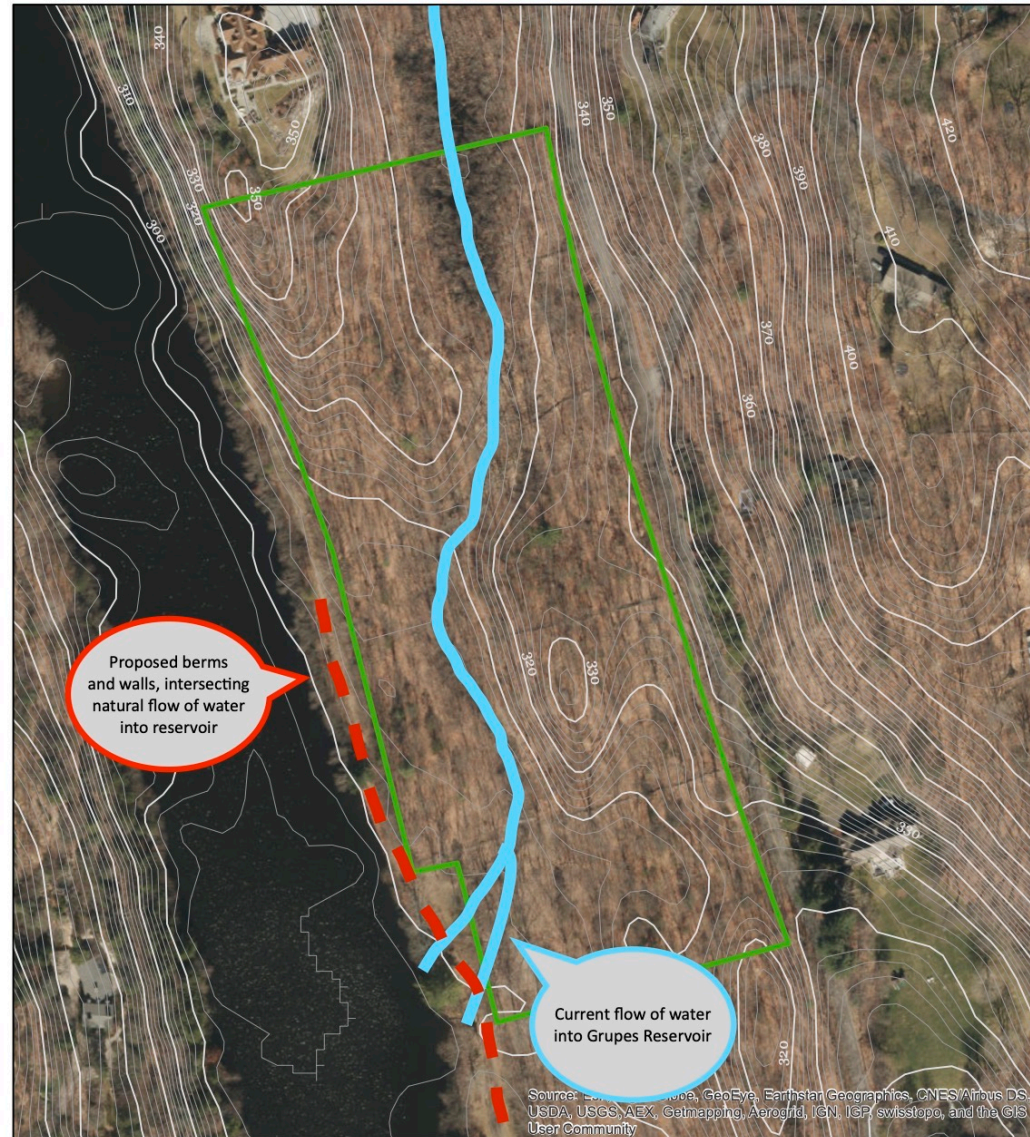
New Canaan
Land Trust

Topo Map (2' elev. marks) Browne Preserve

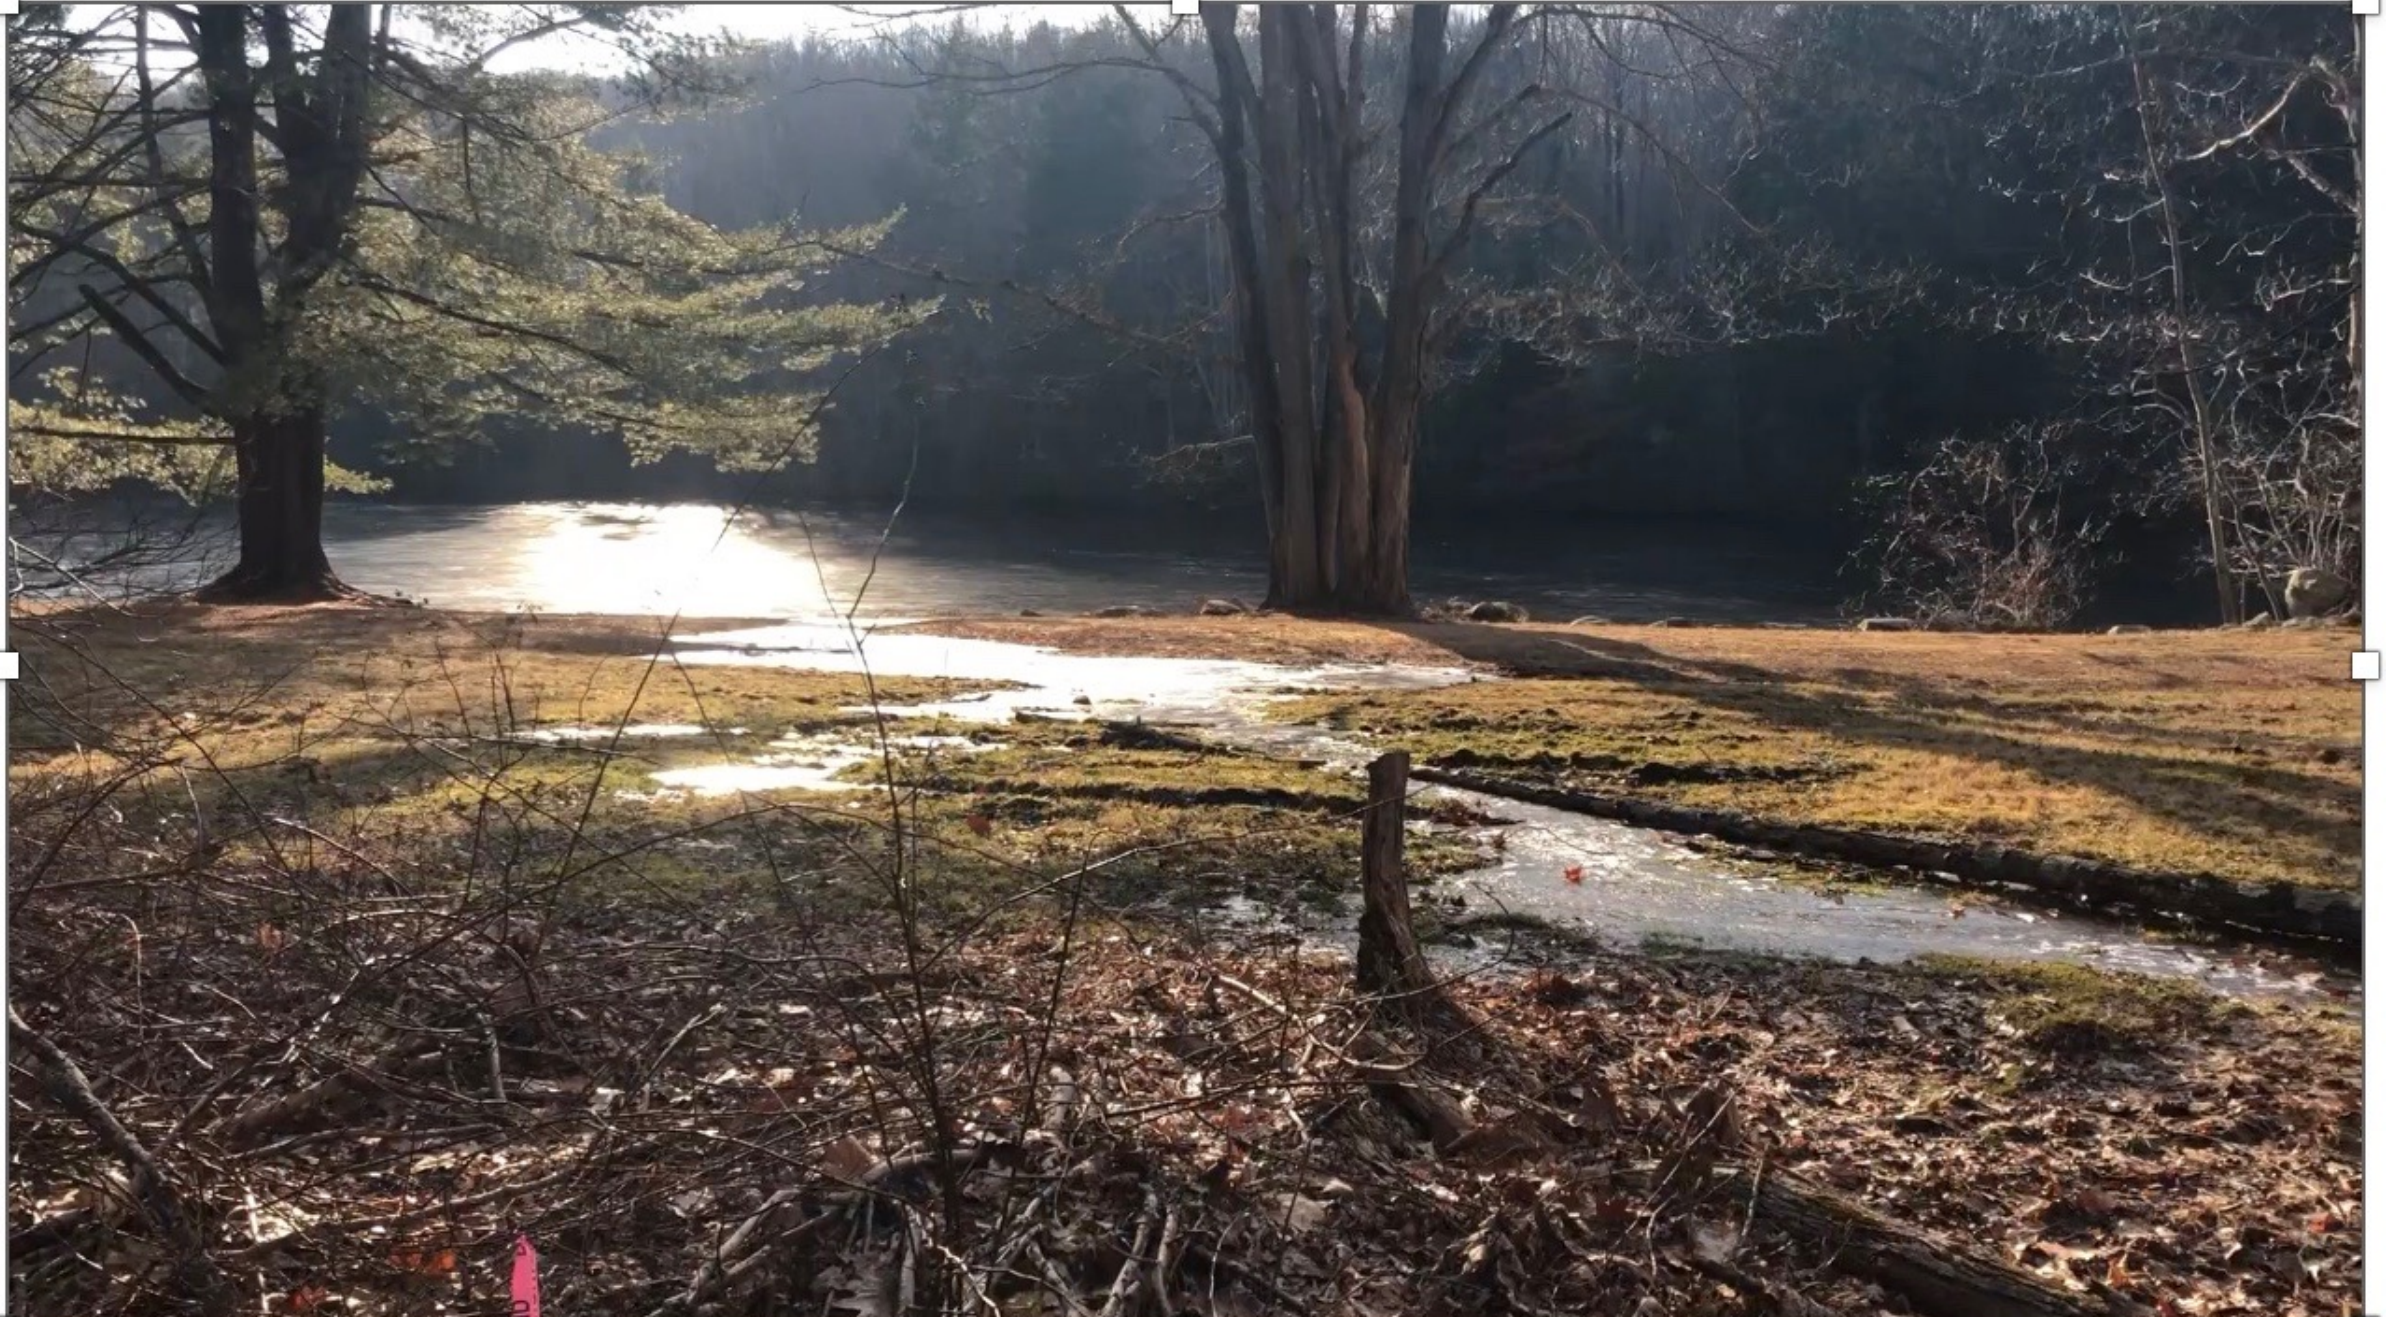
Image 9: Northern-most of the two Intermittent Streams Draining Browne Sanctuary Wetlands to Grupes Reservoir

See images 9-10, images of the wetlands after rain showing the areas that were removed from the survey and that are plainly wetlands/streams.

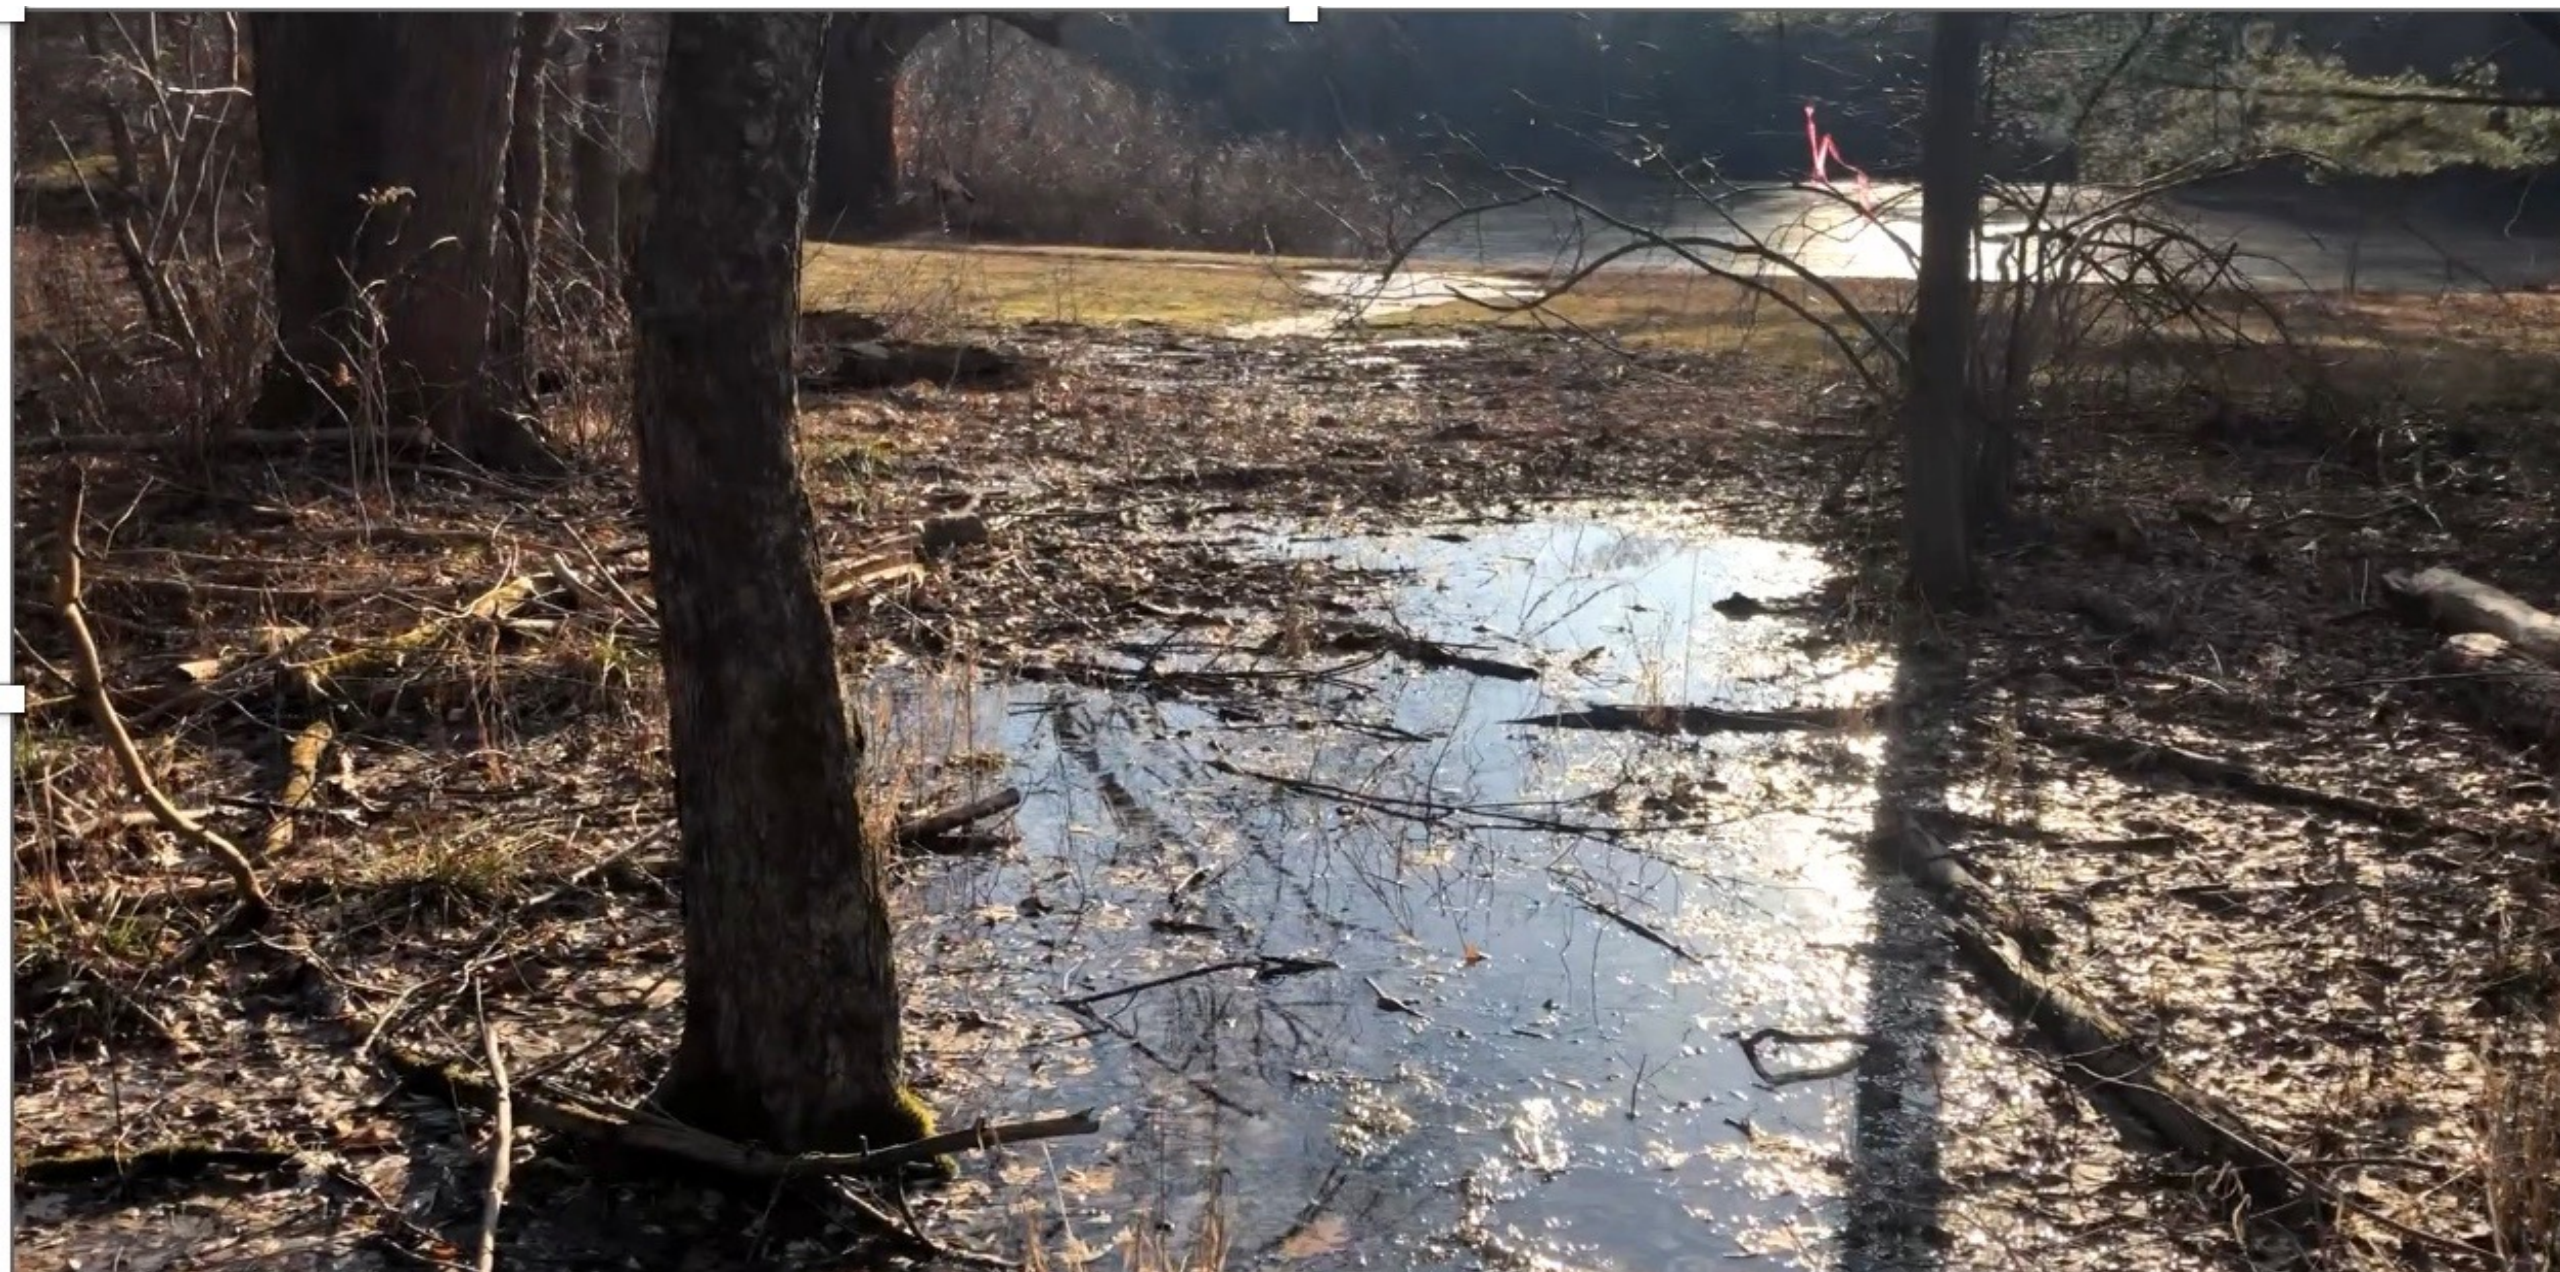
Image 10: Southern-most of the two Intermittent Streams Draining Browne Sanctuary Wetlands to Grupes Reservoir

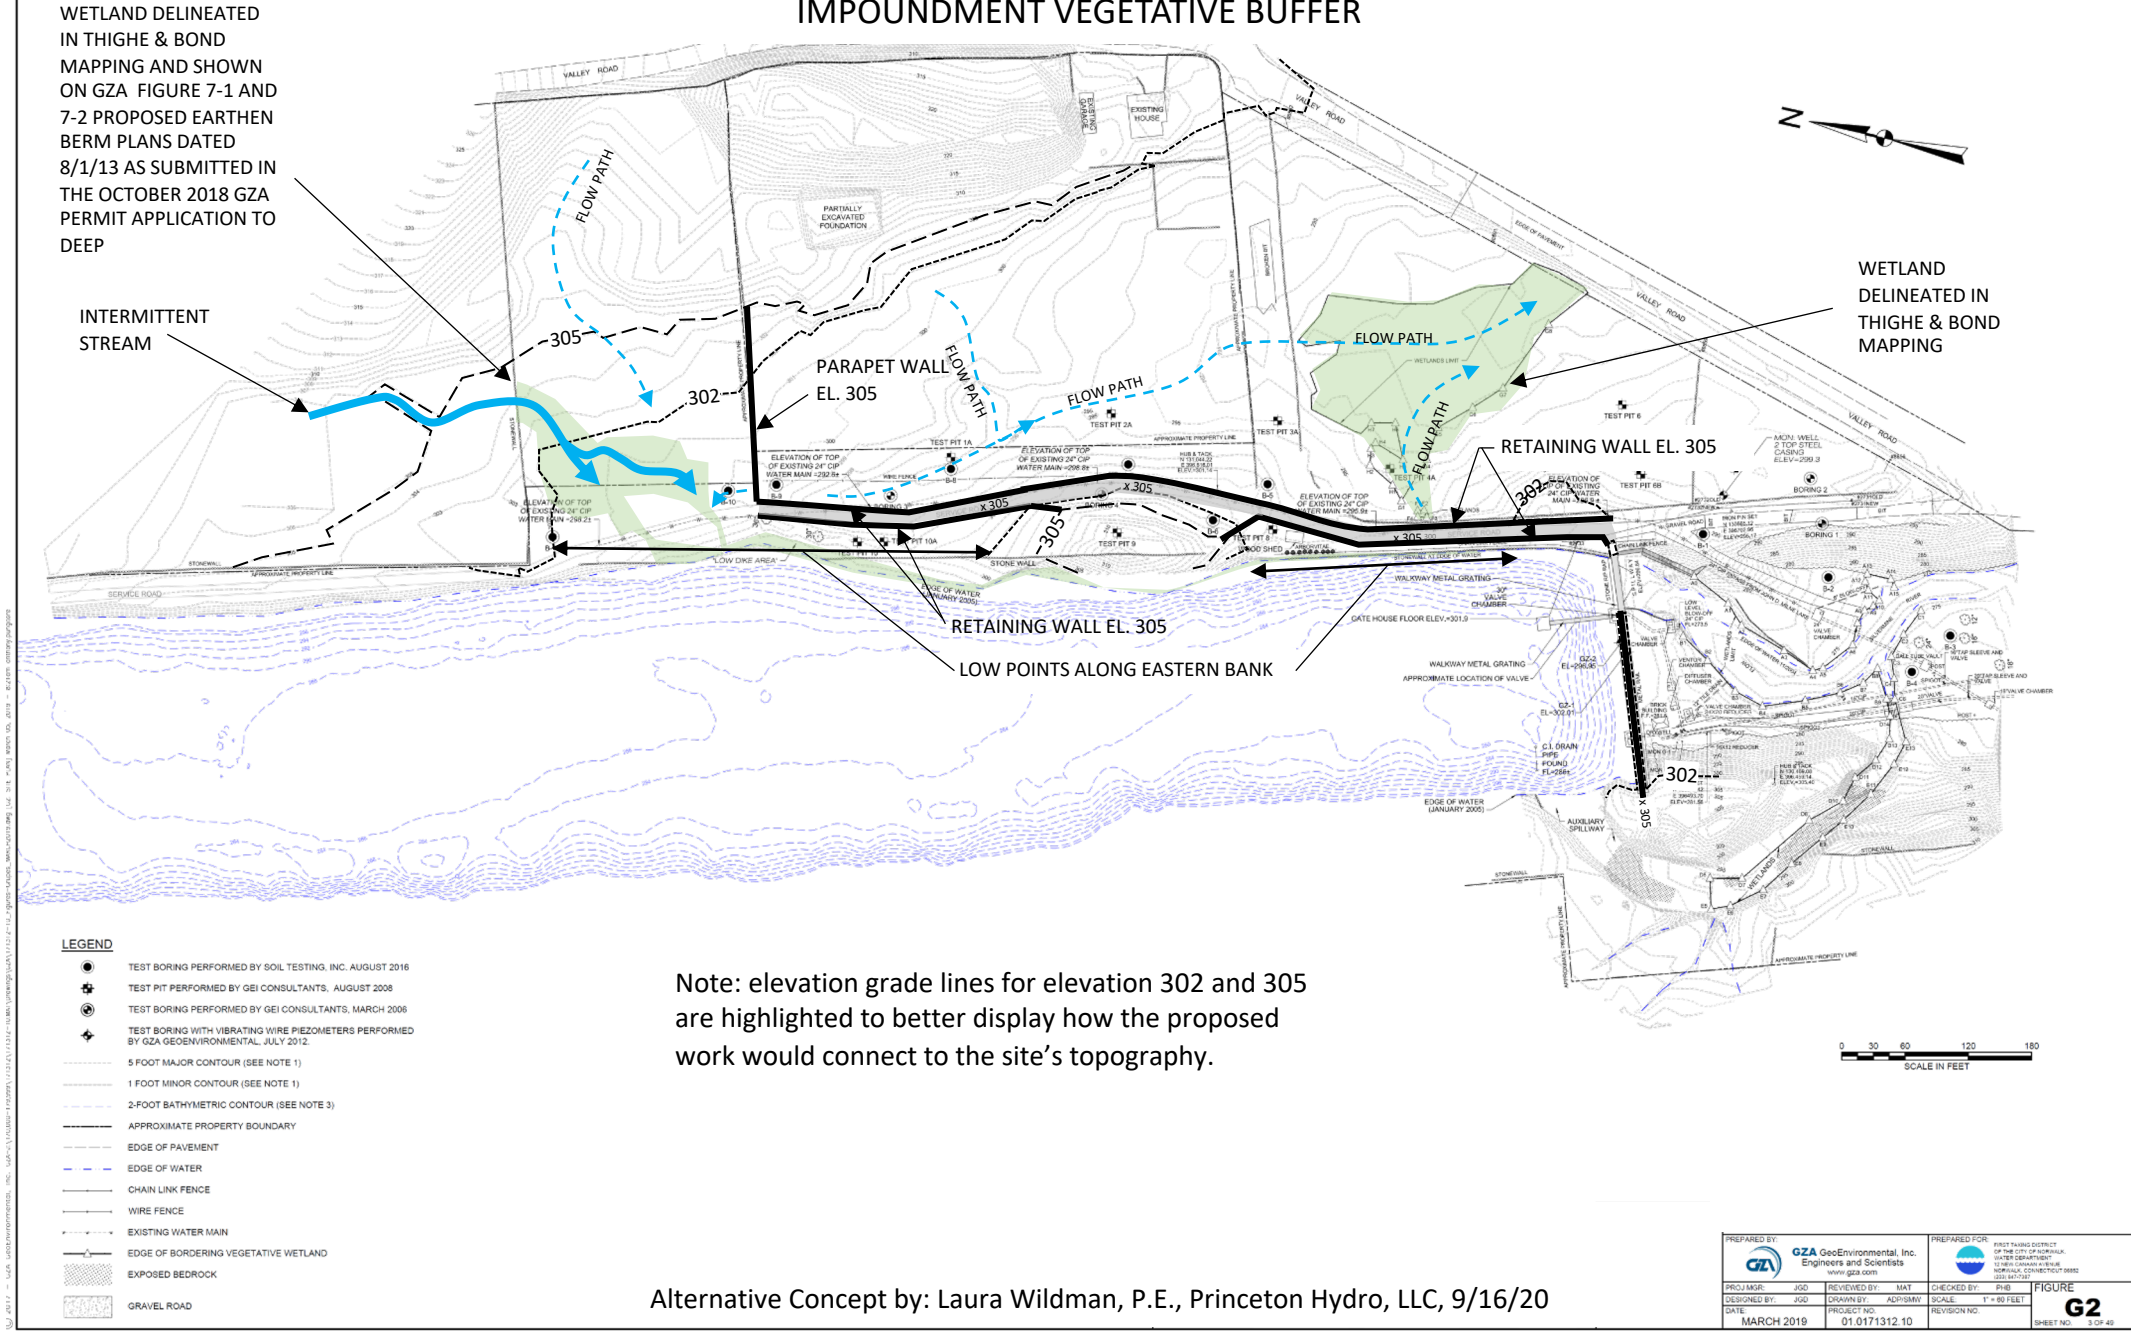
FIGURE 4: POTENTIAL ALTERNATIVE TO RAISE DAM TO EL. 305 COULD BE MODIFIED TO MINIMIZE IMPACTS TO WETLAND AND THE IMPOUNDMENT VEGETATIVE BUFFER

3. It is NRWA's position that there are viable alternatives to this project which would repair the dam to safety and would be less damaging to the wetlands and the riparian buffer along the reservoir and that were not considered during the planning or permitting process. During adjudication, engineer Laura Wildman, then of Princeton Hydro and now at Save the Sound, and wetland scientist, William Kenny, of William Kenny Associates, presented ideas for alternatives, three of which are illustrated in Figures 2,3 and 4 below.
